Te Pahu Road Bridge Pier Stabilisation

TE PAHU ROAD (RP 17236) BRIDGE PILE DEFECT REMEDIAL INVESTIGATIONS

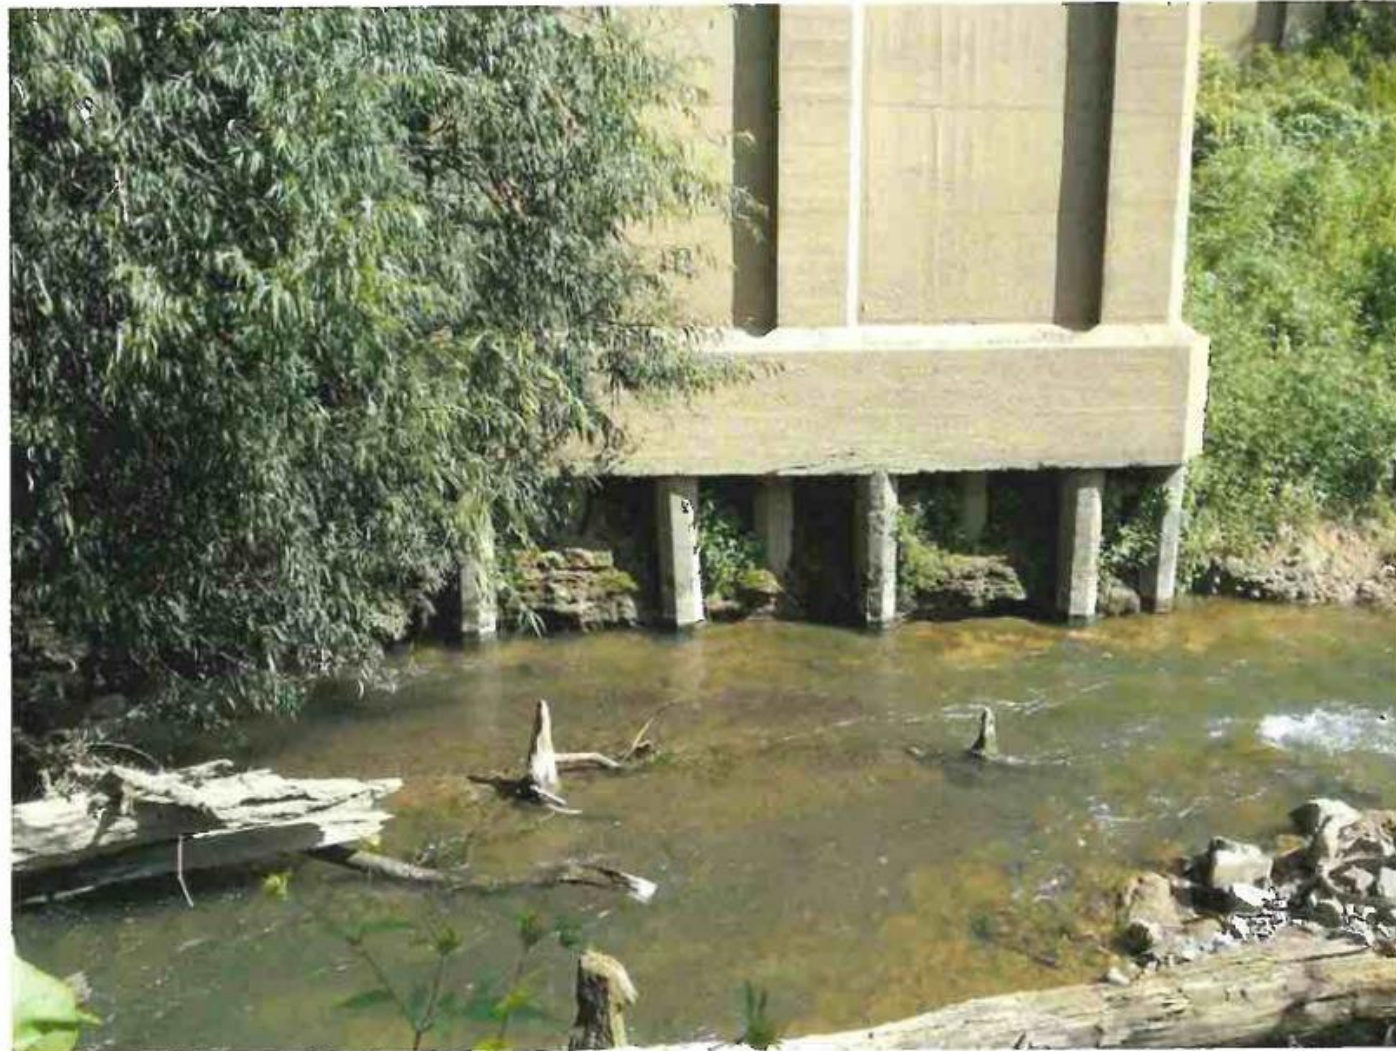
Pier / Column: Piles at piers C & D are exposed up to 1.5m.

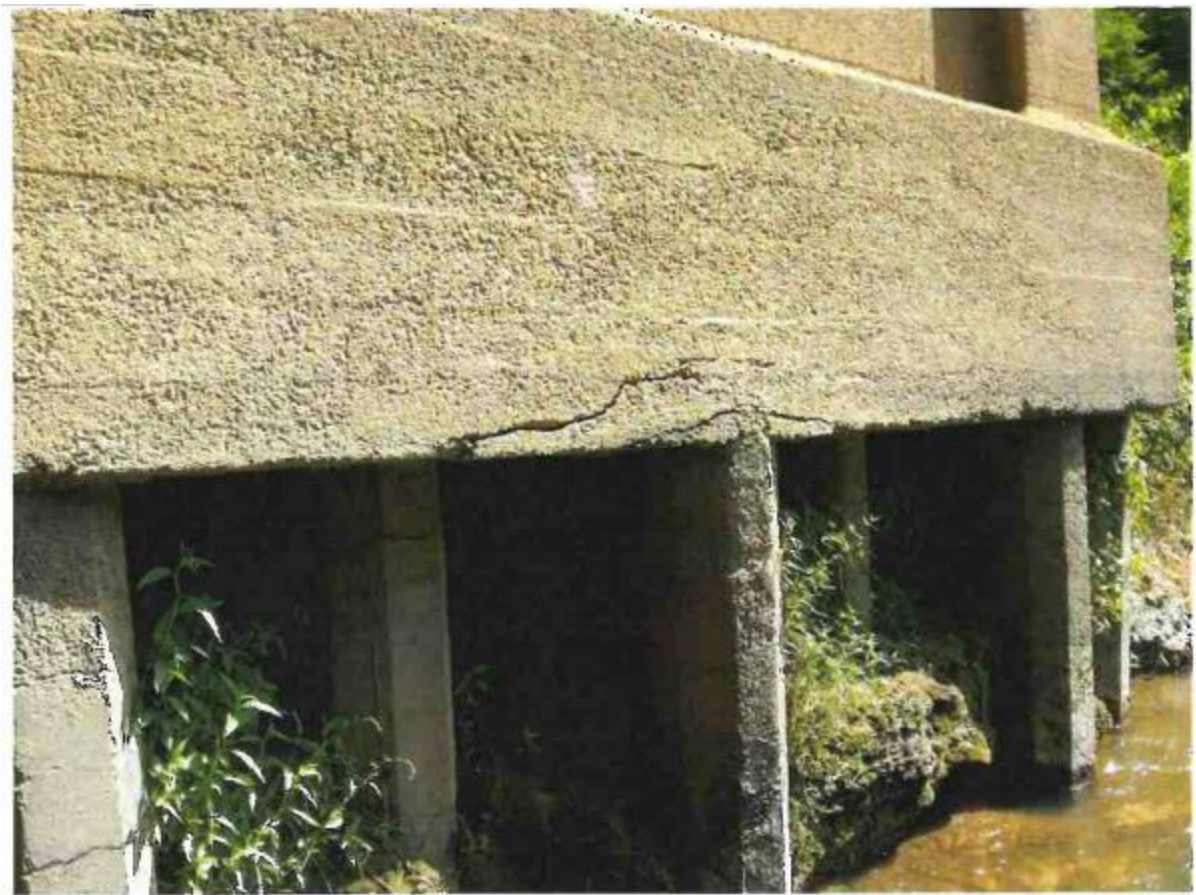
Pier / Column: Spall to lower pier above pile.

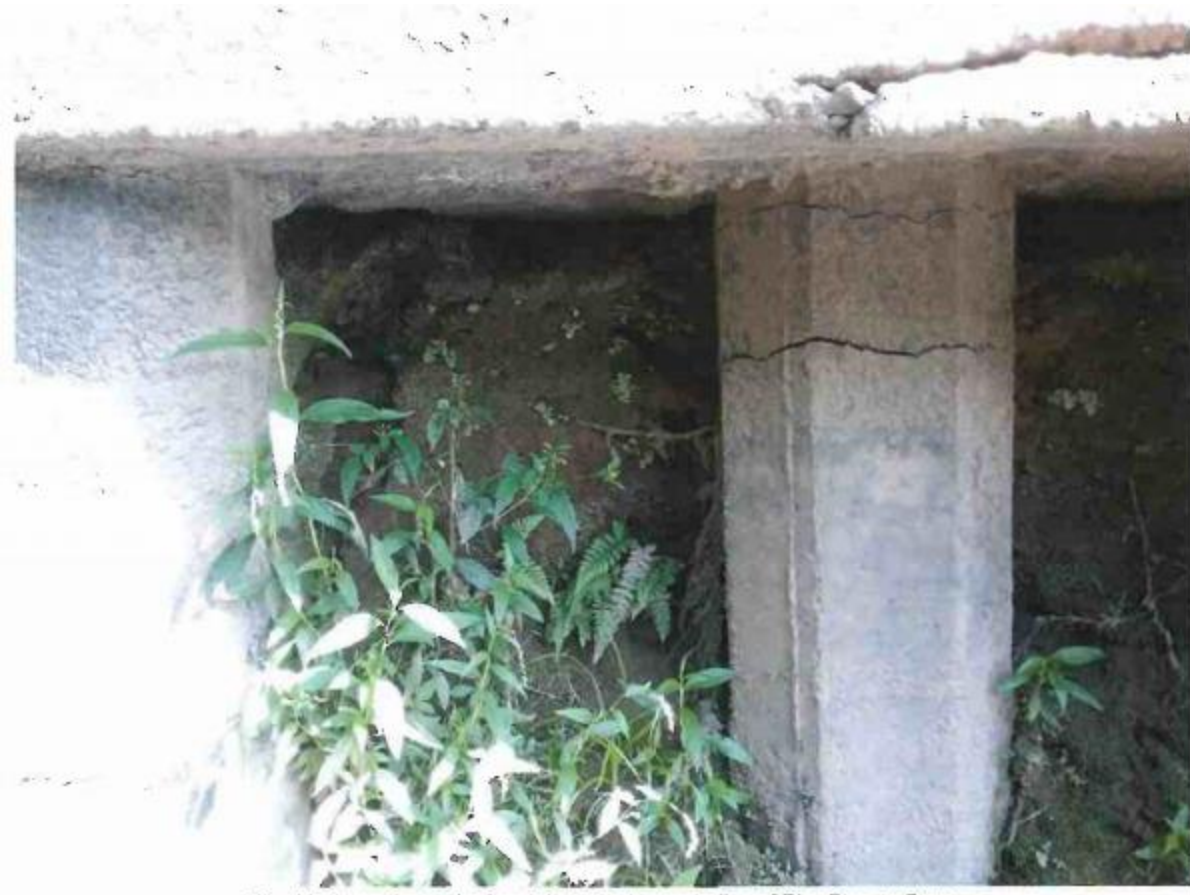
Pier / Column: Large horizontal cracks to most piles of Pier D up to 5mm.

Comments and recommendations for maintenance/repairs		
Suggested remedial work	Priority (H/M/L)	Estimated cost
Break out & repair all spalls to cantilever.	M	\$10,000
Cracks to piles of Pier D are below water level. Cracks noted in last inspection however appear relatively recent. Investigate cause of cracks and develop a repair solution.	H	\$25,000
Remove detritus & vegetation from kerbs.	H	\$500

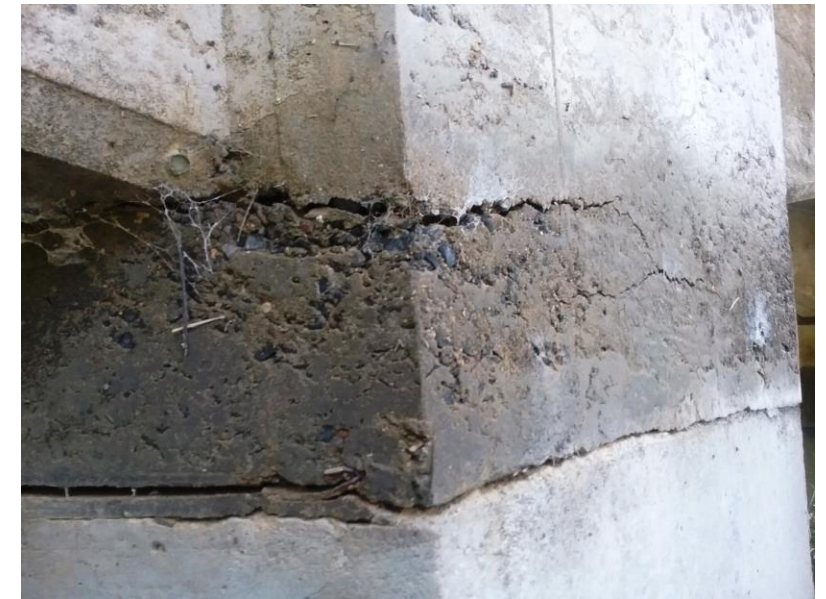
.... found cracks at the top of the pier too (hinging)

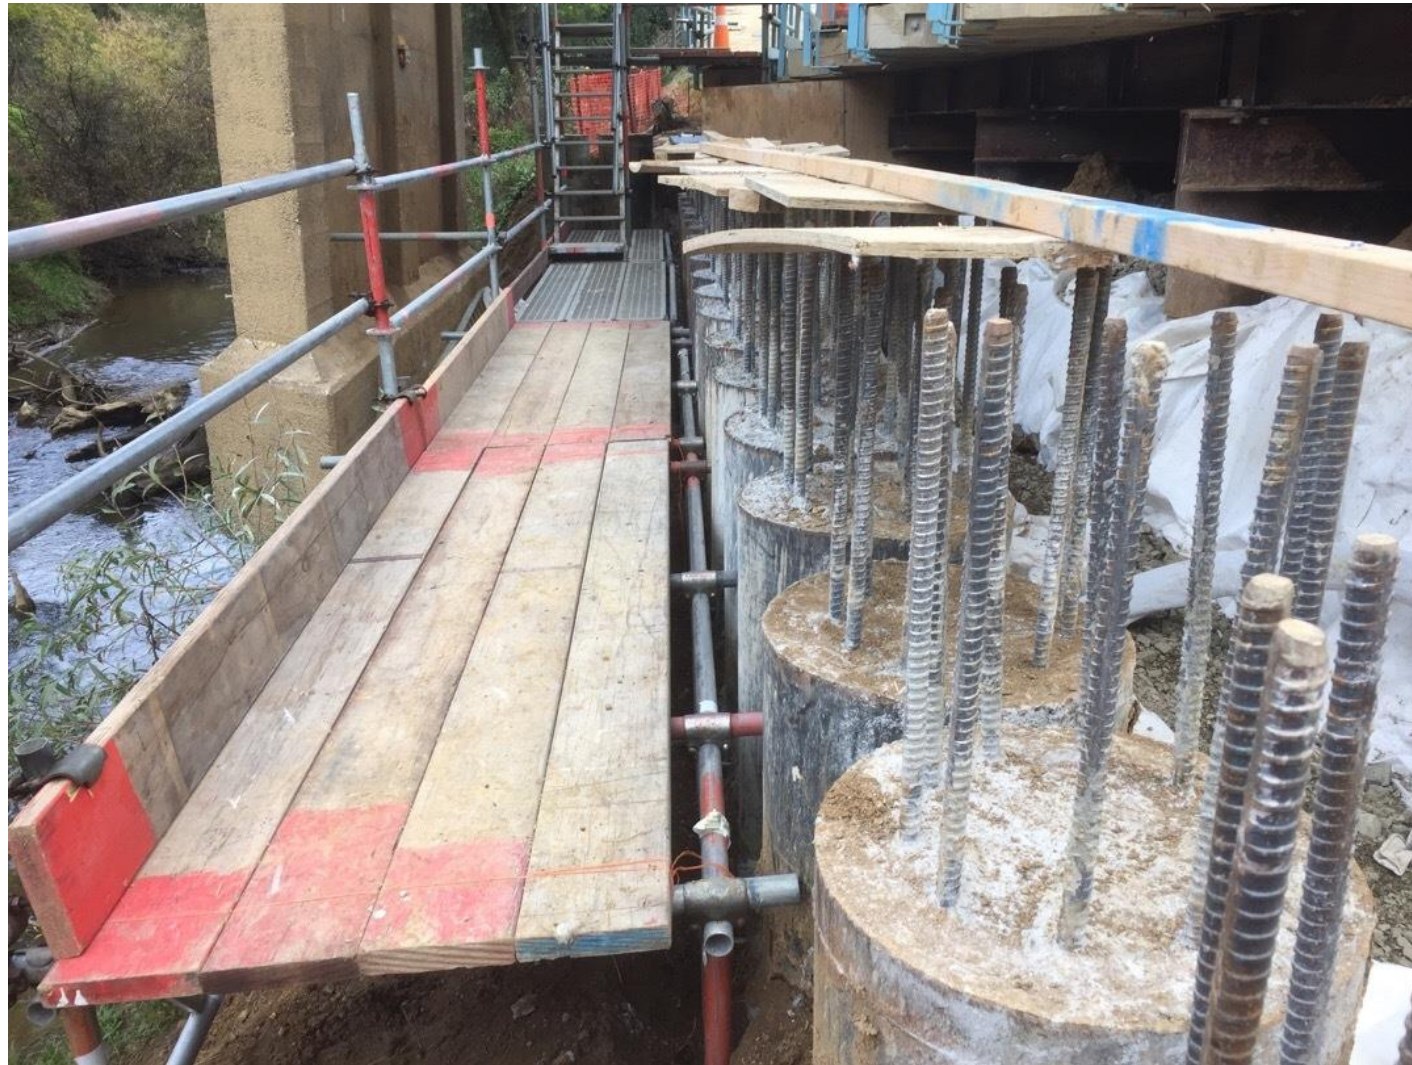
Every 3rd pile installed to reduce vibration, 20 metres deep piles. One wet afternoon Pier D decided to move 30mm.

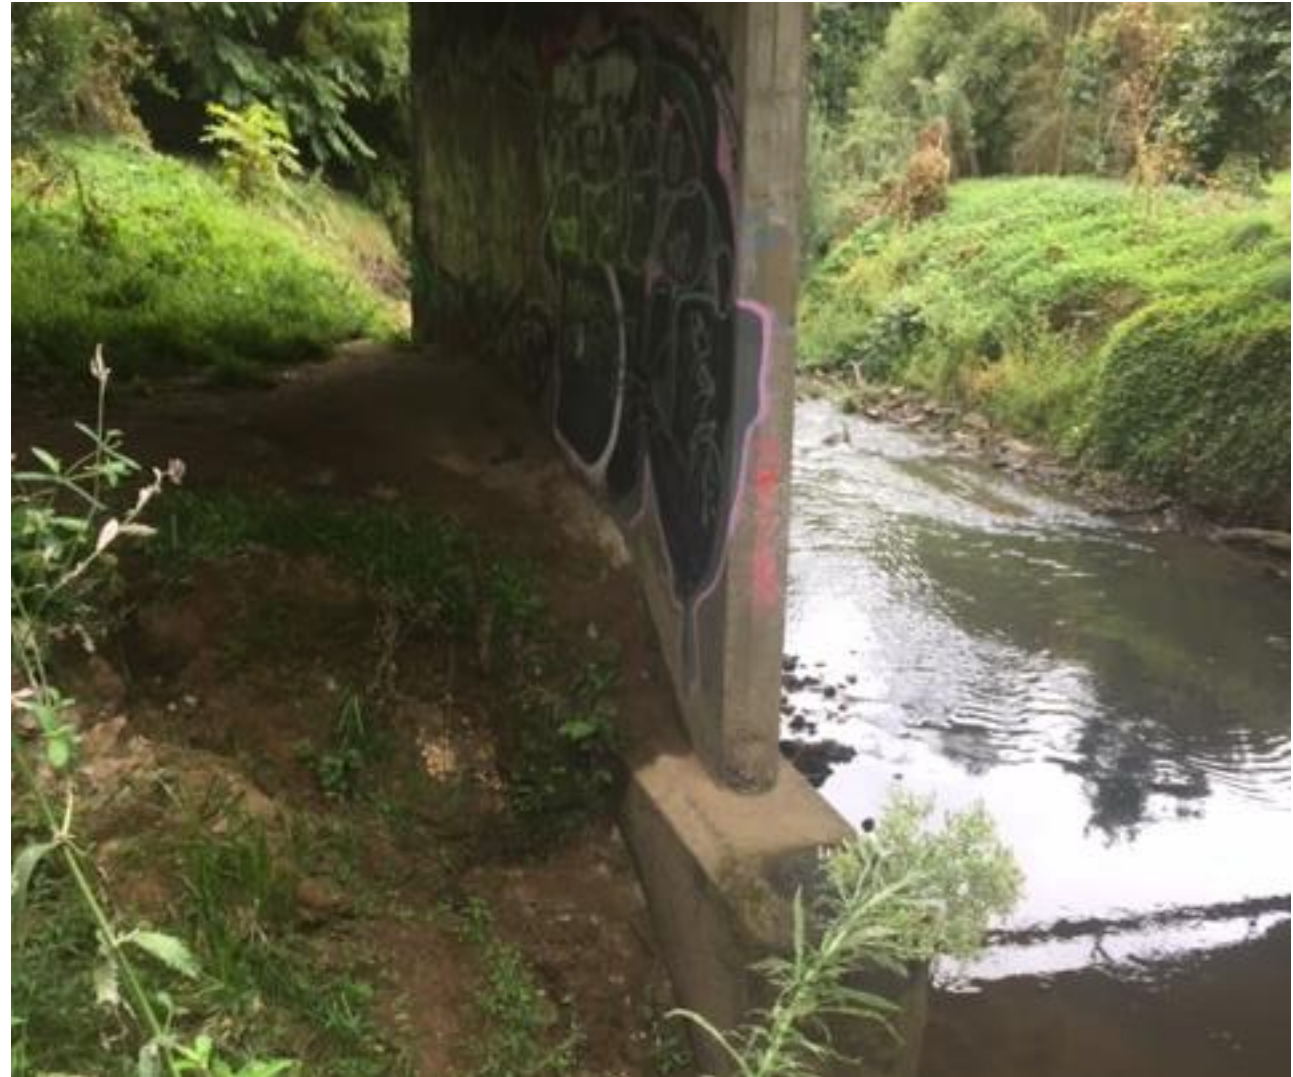
Mangauika Road
Bridge, Pirongia

The concrete
probably once went
to ground level

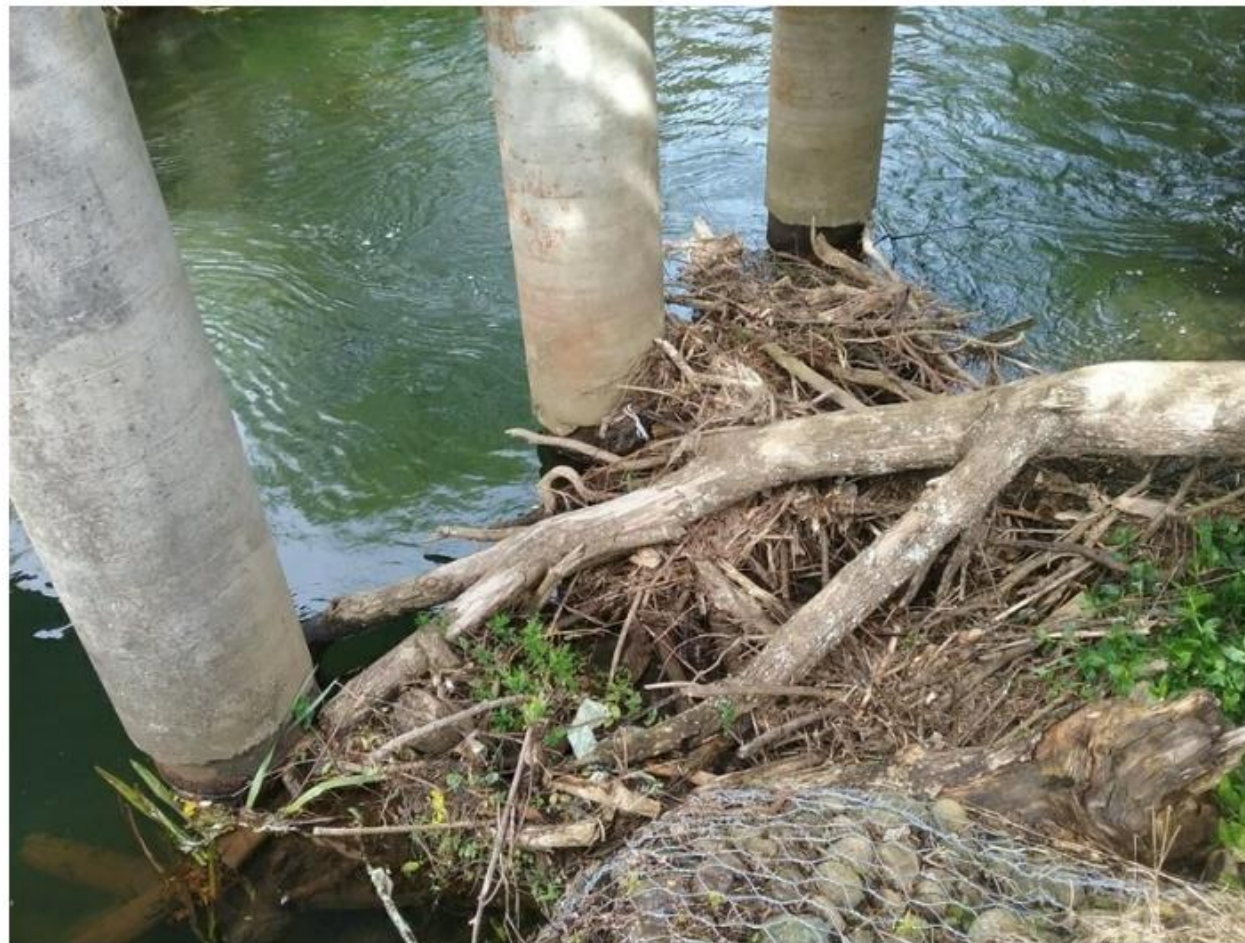
Invert / River Bed (Element 25): Log jam impeding flow at A.

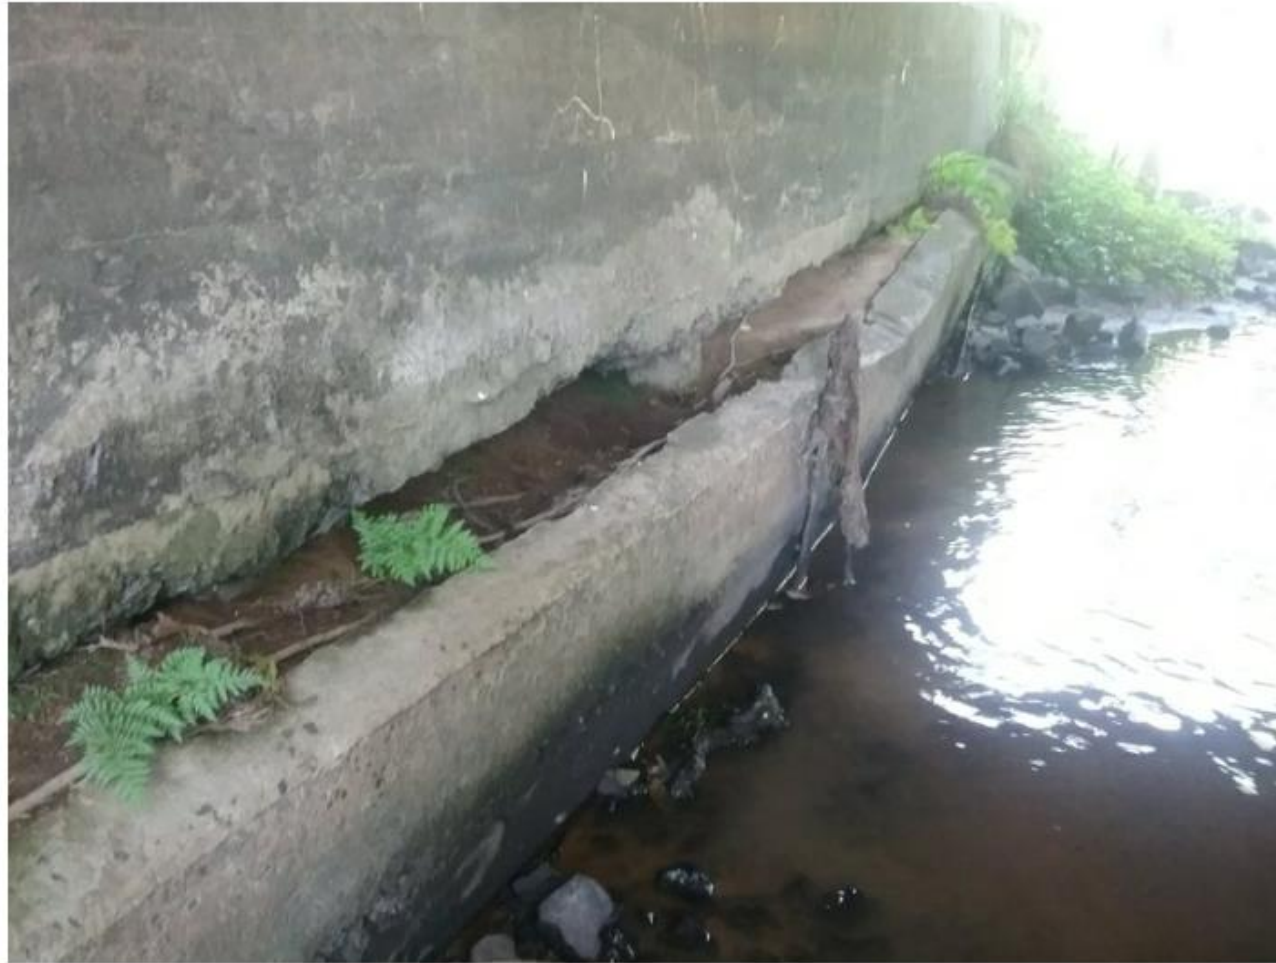
Whitehall Road Bridge

Scour (Element 29): Failure of abutment B protection structure.
