Addressing Safety Issues – Takaka Resource Recovery Centre Upgrade

Drivers for upgrade

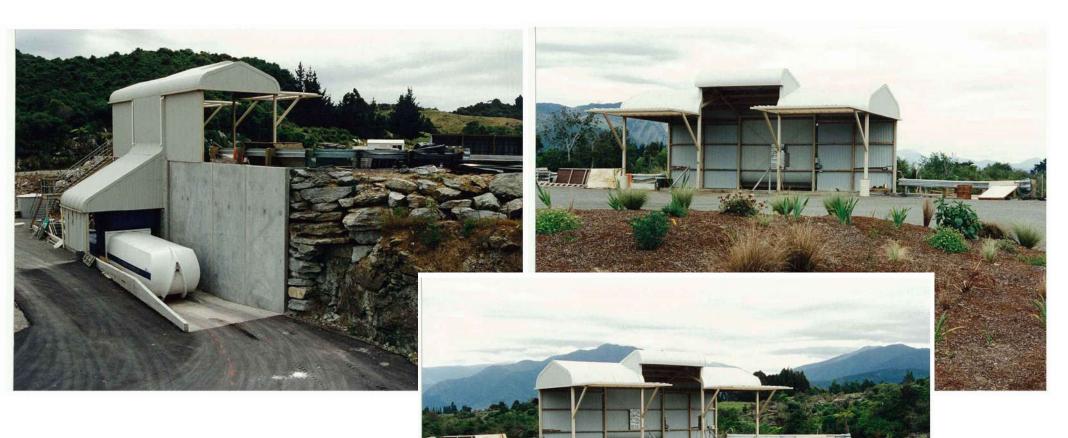
- Opened in 1996
- Site previously a quarry

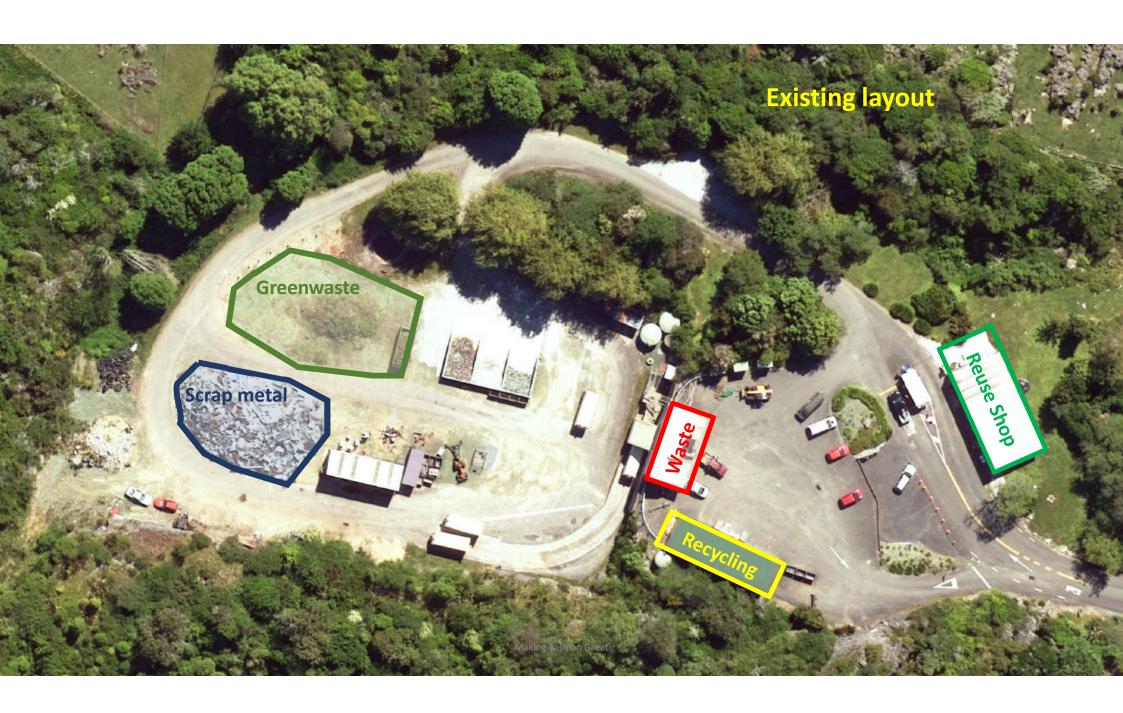
- Compactor renewal + falling and jamming risks in compactor
- Congestion on upper level delays and risks
- Potential conflicts: customer traffic, pedestrians and contractor's plant
- Wasted space on lower level
- Inefficient handling of recycling
- Need to weigh incoming customer loads

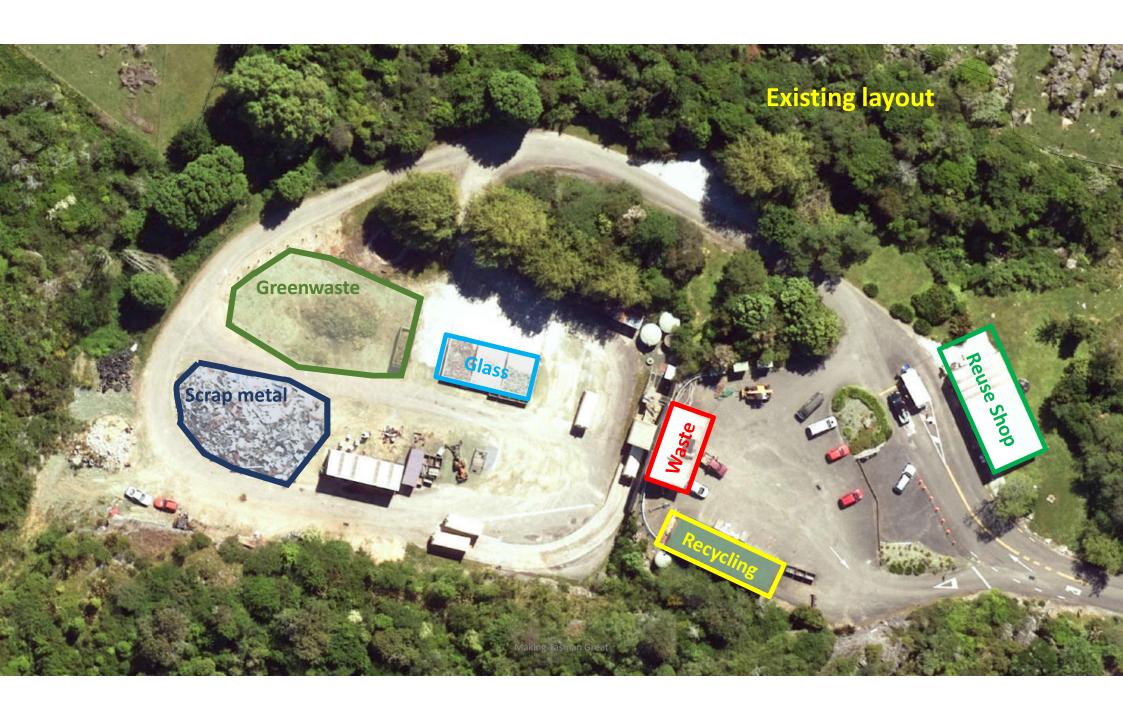
Design timeline

Initially planed in a staged manner, as per strategic development plan (2011)

Initially no plan for relocation of compactor and concentration of services on upper level

In 2017 compactor renewal due – end of life, prone to blockage and flooding and high fall risks

Considered safety in use and in construction, current site issues and constructability

This led us to compactor relocation

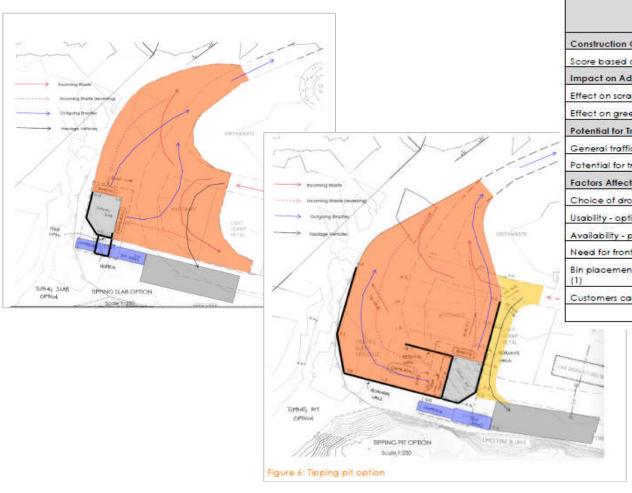
Lower level – options analysis

able 13: Evaluation of "detailed" concept designs for lower level

Factor	Tipping Slab Option	Tipping Pit Option	Tipping Hopper Option
Construction Costs	\$658,999	\$785,410	\$731,787
Score based on cost estimate	3.	1	2
Impact on Adjoining Activities			
Effect on scrap metal area	3	2	3
Effect on greenwaste area	3	2	1
Potential for Traffic Conflicts			
General traffic flow (clockwise - 3 or anti-clockwise - 2))	3	3	3
Potential for traffic conflicts between customers	2	2	2
Factors Affecting Operations			
Choice of drop-off bays (1 side - 1; 2 sides - 2; 3 sides - 3)	2	2	1
Usability - options for ramp drop-off (skip bins) and at floor level	2	3	2
Availability - provision of storage in case of breakdowns	3	3	2
Need for front end loader (No - 3; Sometimes - 2; Yes - 1)	-1	1	2
Bin placement & pull out in straight line (3) or requires turning (1)	3	3	3
Customers can reverse straight (2) or must do so on a curve (1)	2	1	2
Total	27	23	23

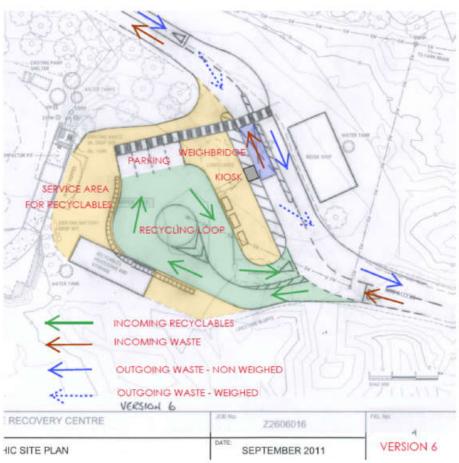
Upper level – options analysis

Table 6: Evaluation of recycling loop

FACTOR	Version 1	Version 2	Version 3	Version 4	Version 5	Version 6
Factors Affecting Construction Costs (described, not quantified)						
Uses existing ramps for entry and exit	1	3	2	2	2	2
Additional road construction required	3	3	1	1	1	1
Potential for Traffic Conflicts						
Accessibility - bypasses the kiosk and/or weighbridge.	2	1	3	3	3	. 3
Factors Affecting Operations						
Contractor access for recyclables service area	2	2	3	3	3	3
Security against non-paying customers	2	1	3	3	3	3
Room for Expansion						
Room for expansion of bin areas	2	2	3	3	3	3
Sub-Total	12	12	15	15	15	15

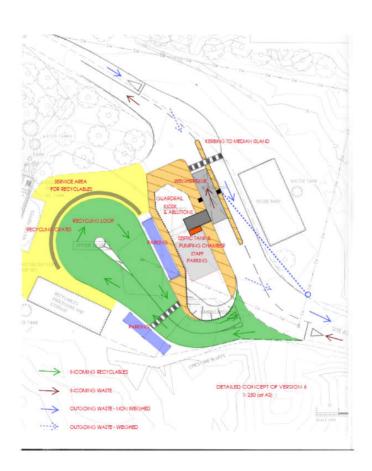
Upper level – concept design and cost estimate

Table 8: Summary of cost estimate for the recycling drop-off loop, weighbridge and klosk

Description	Estimate
Preliminary and General	\$44,300
General Site Clearance	\$3,000
Recycling Drop-off Loop	\$26,000
Roadworks to Lower Level	\$20,750
Civils for Weighbridge and Surrounding Area	\$74,383
Weighbridge	\$100,000
Kiosk and Ablutions	\$71,000
SUB-TOTAL	\$339,433
Contingency @ 20%	\$68,000
Design Fees @ 5%	\$20,372
Construction monitoring @ 5%	\$20,372
TOTAL	\$448,176
