EMERGENCY RESPONSE & MANAGING RISK - MATIRI WESTBANK ROAD SLIP

Prepared for **IPWEA Branch Meeting 21 February 2020**

February 2020

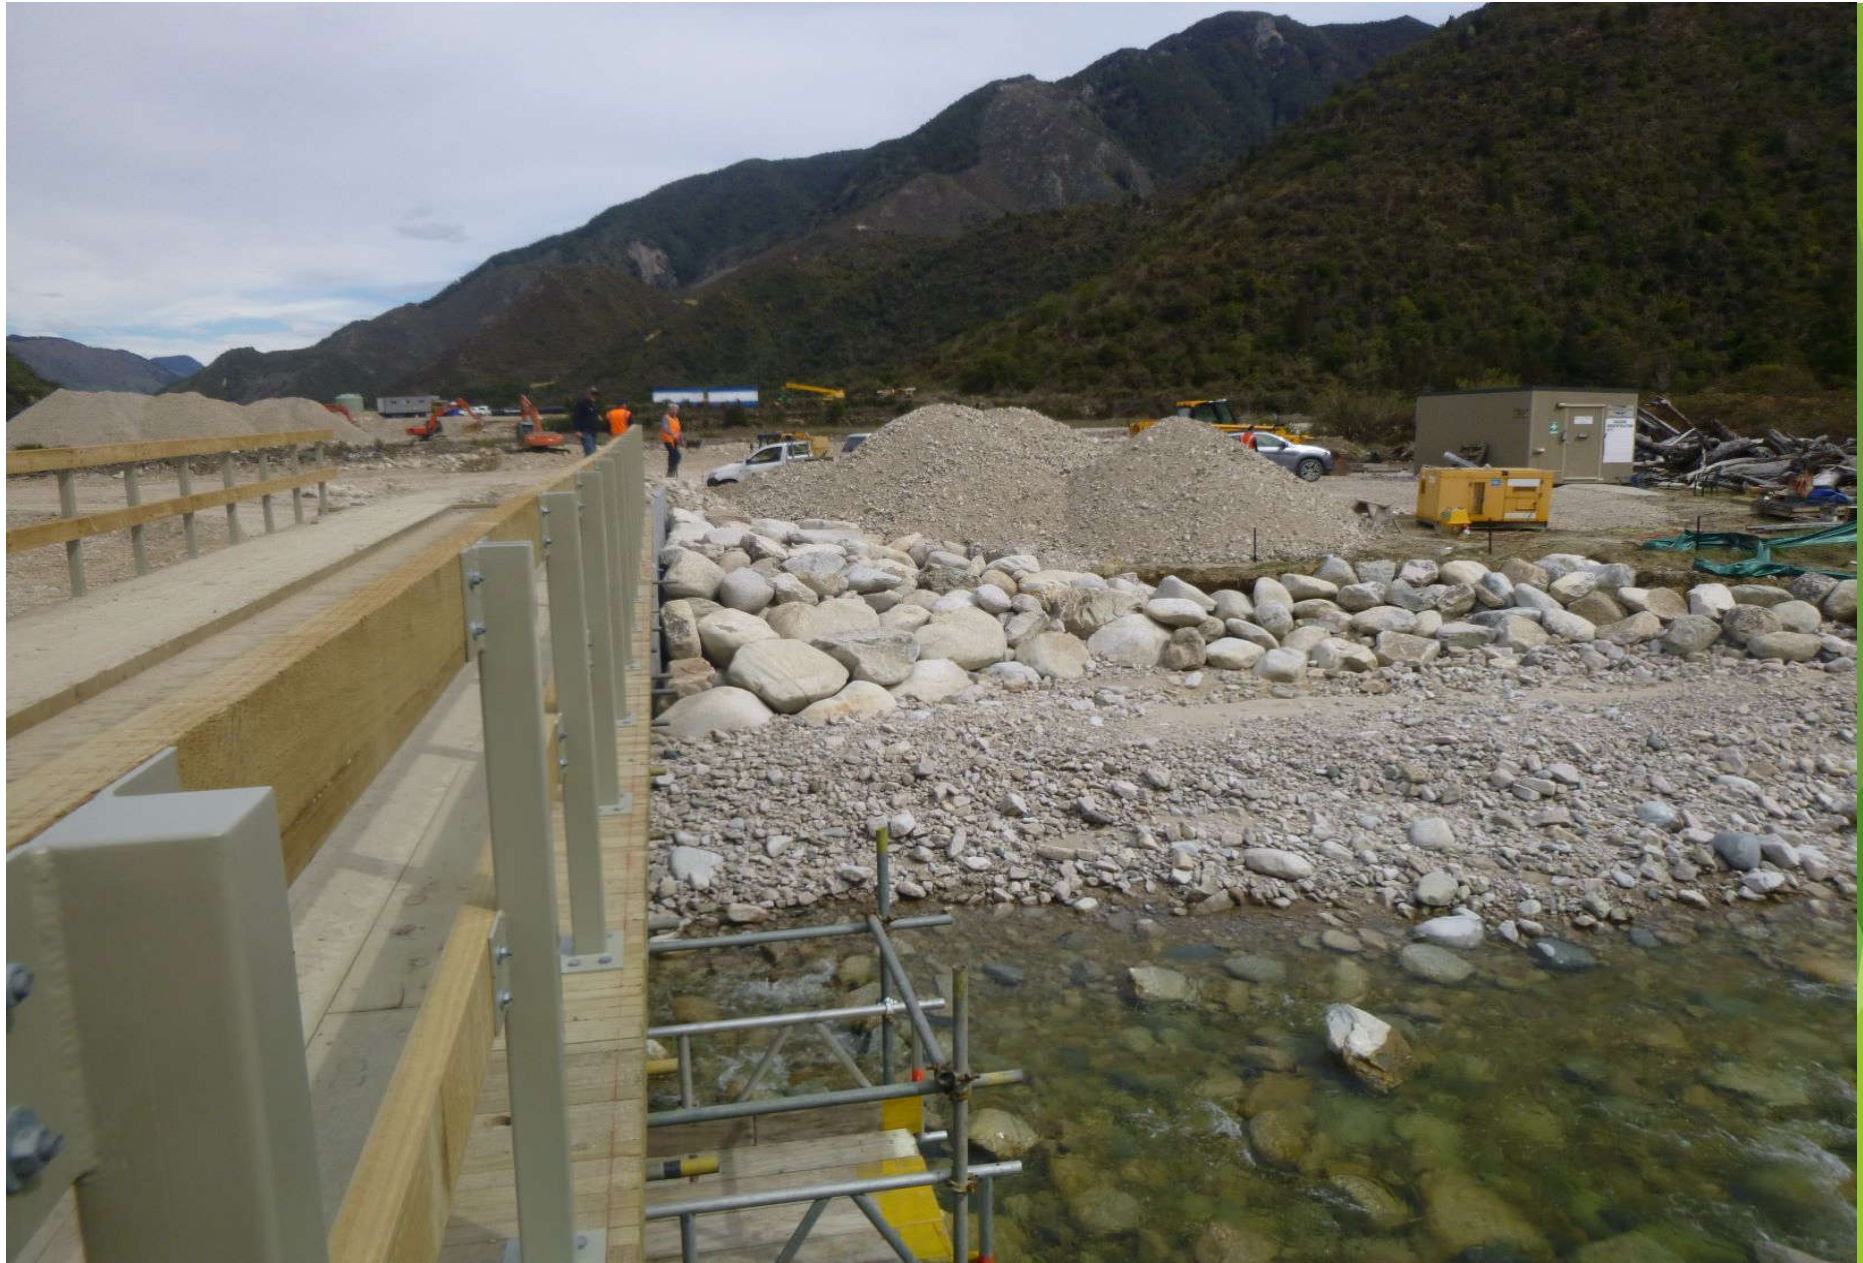
MATIRI WEST BANK ROAD SLIP, DESKTOP STUDY

Approx. extent of slip 2019

Active head scarps 1943

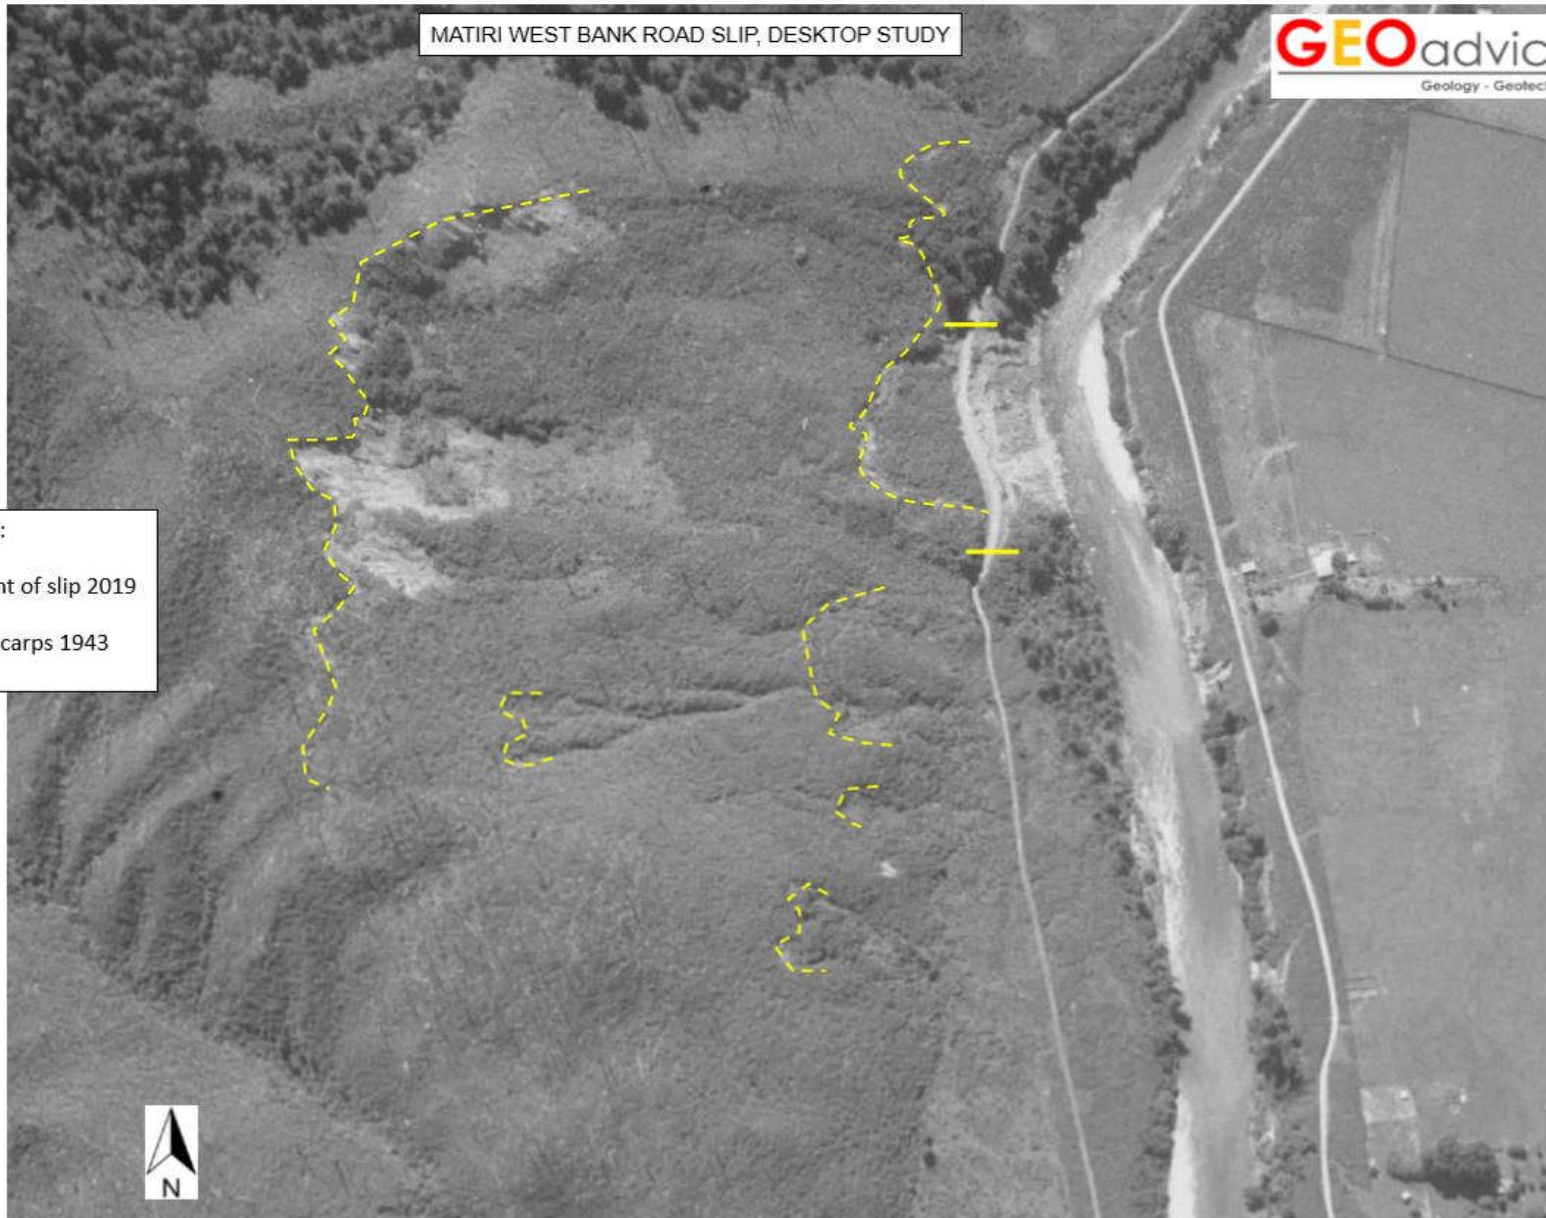
Cumulative vertical displacement of road surface and daily monitored survey pegs at Matiri landslide

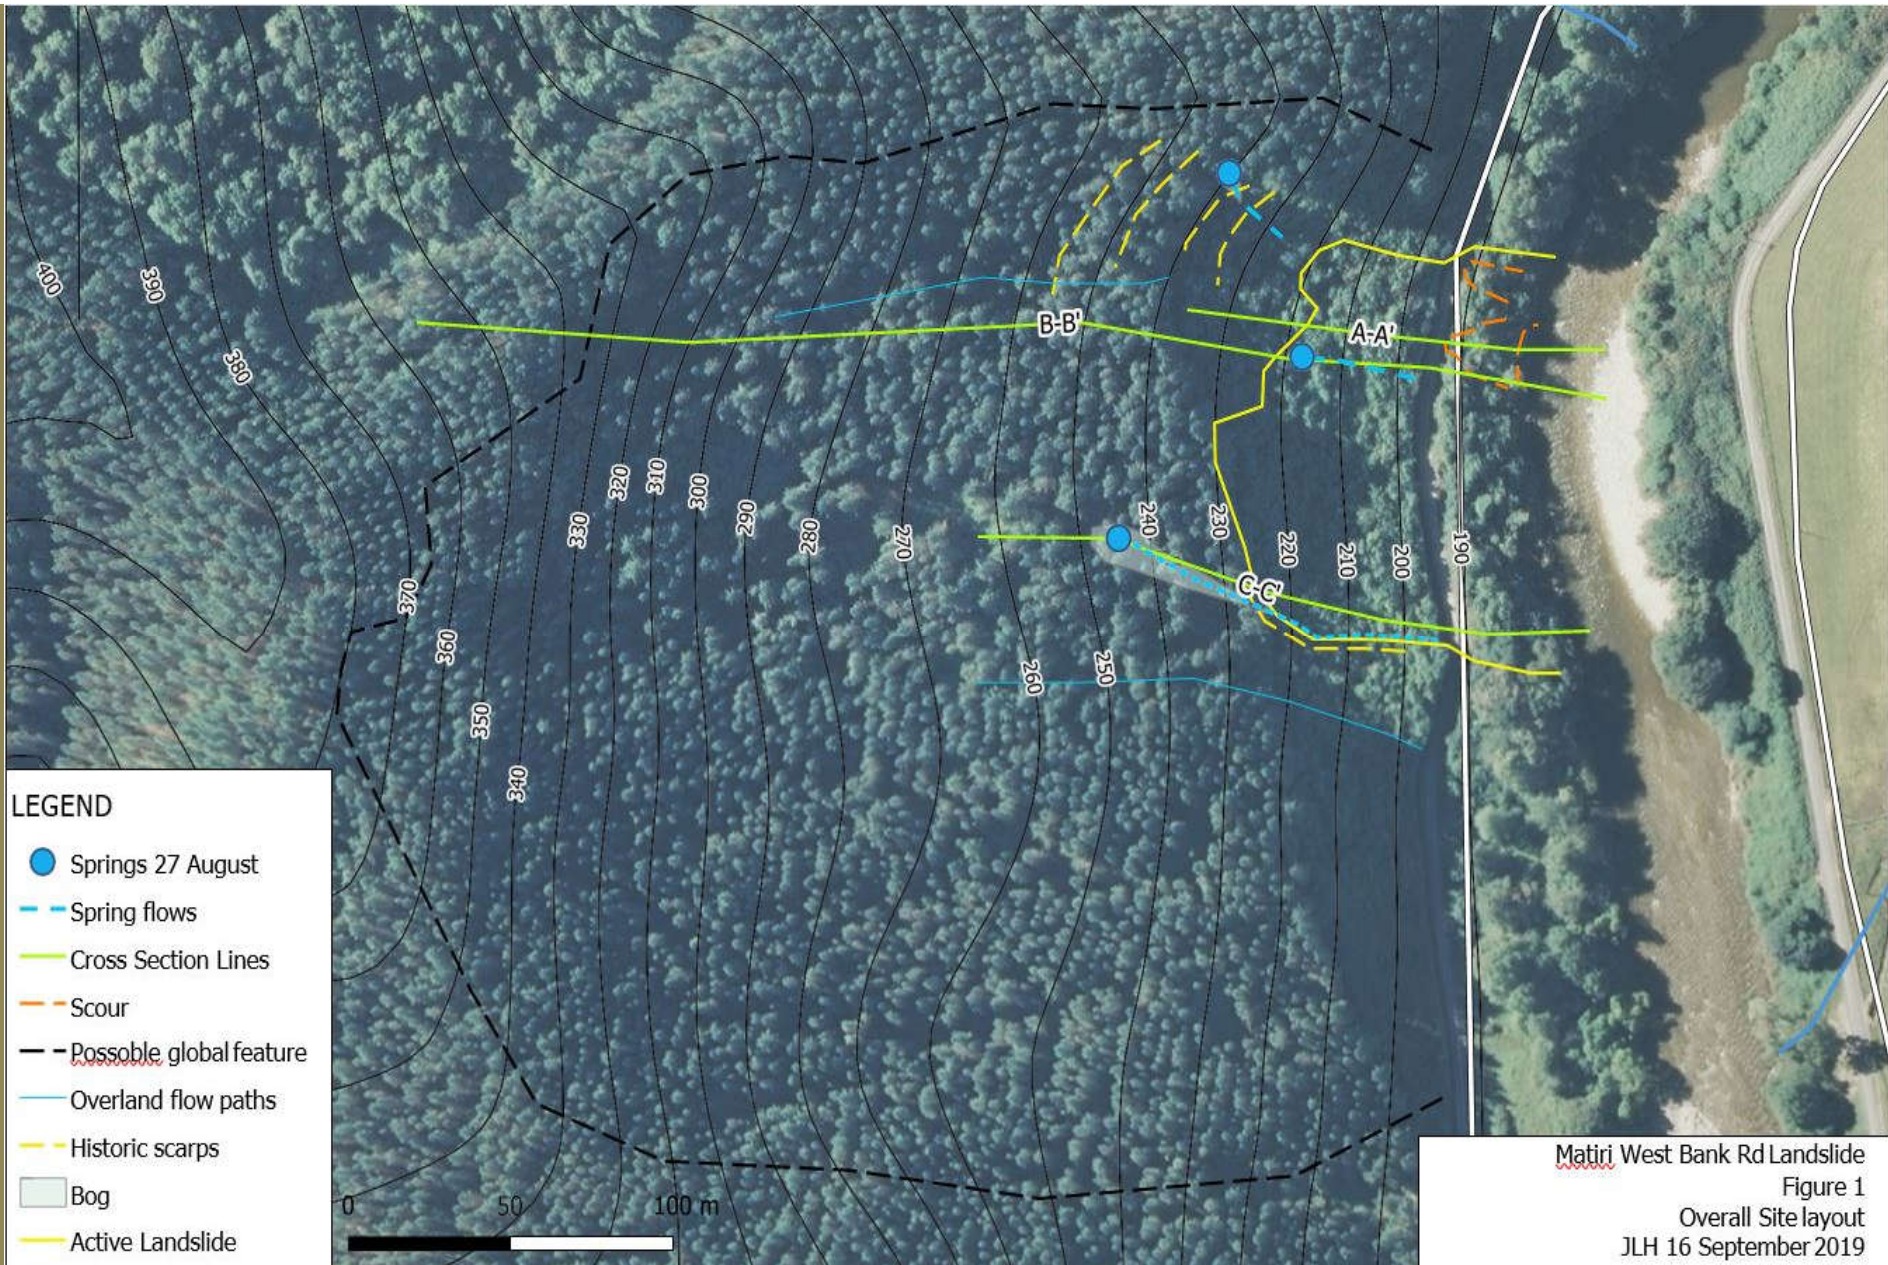
Matiri West Bank Rd Landslide
 Figure 1
 Overall Site layout
 JLH 16 September 2019

Dry cut batter, road bench and swale drain past this point

Culvert 10

- Active Landslide
- New Access Road
- Scour
- Possible global feature
- Overland flow paths
- Historic scarps
- Spring flows
- Springs (27 August)
- Bog
- Cracks (15 August)
- Contours
- Roads

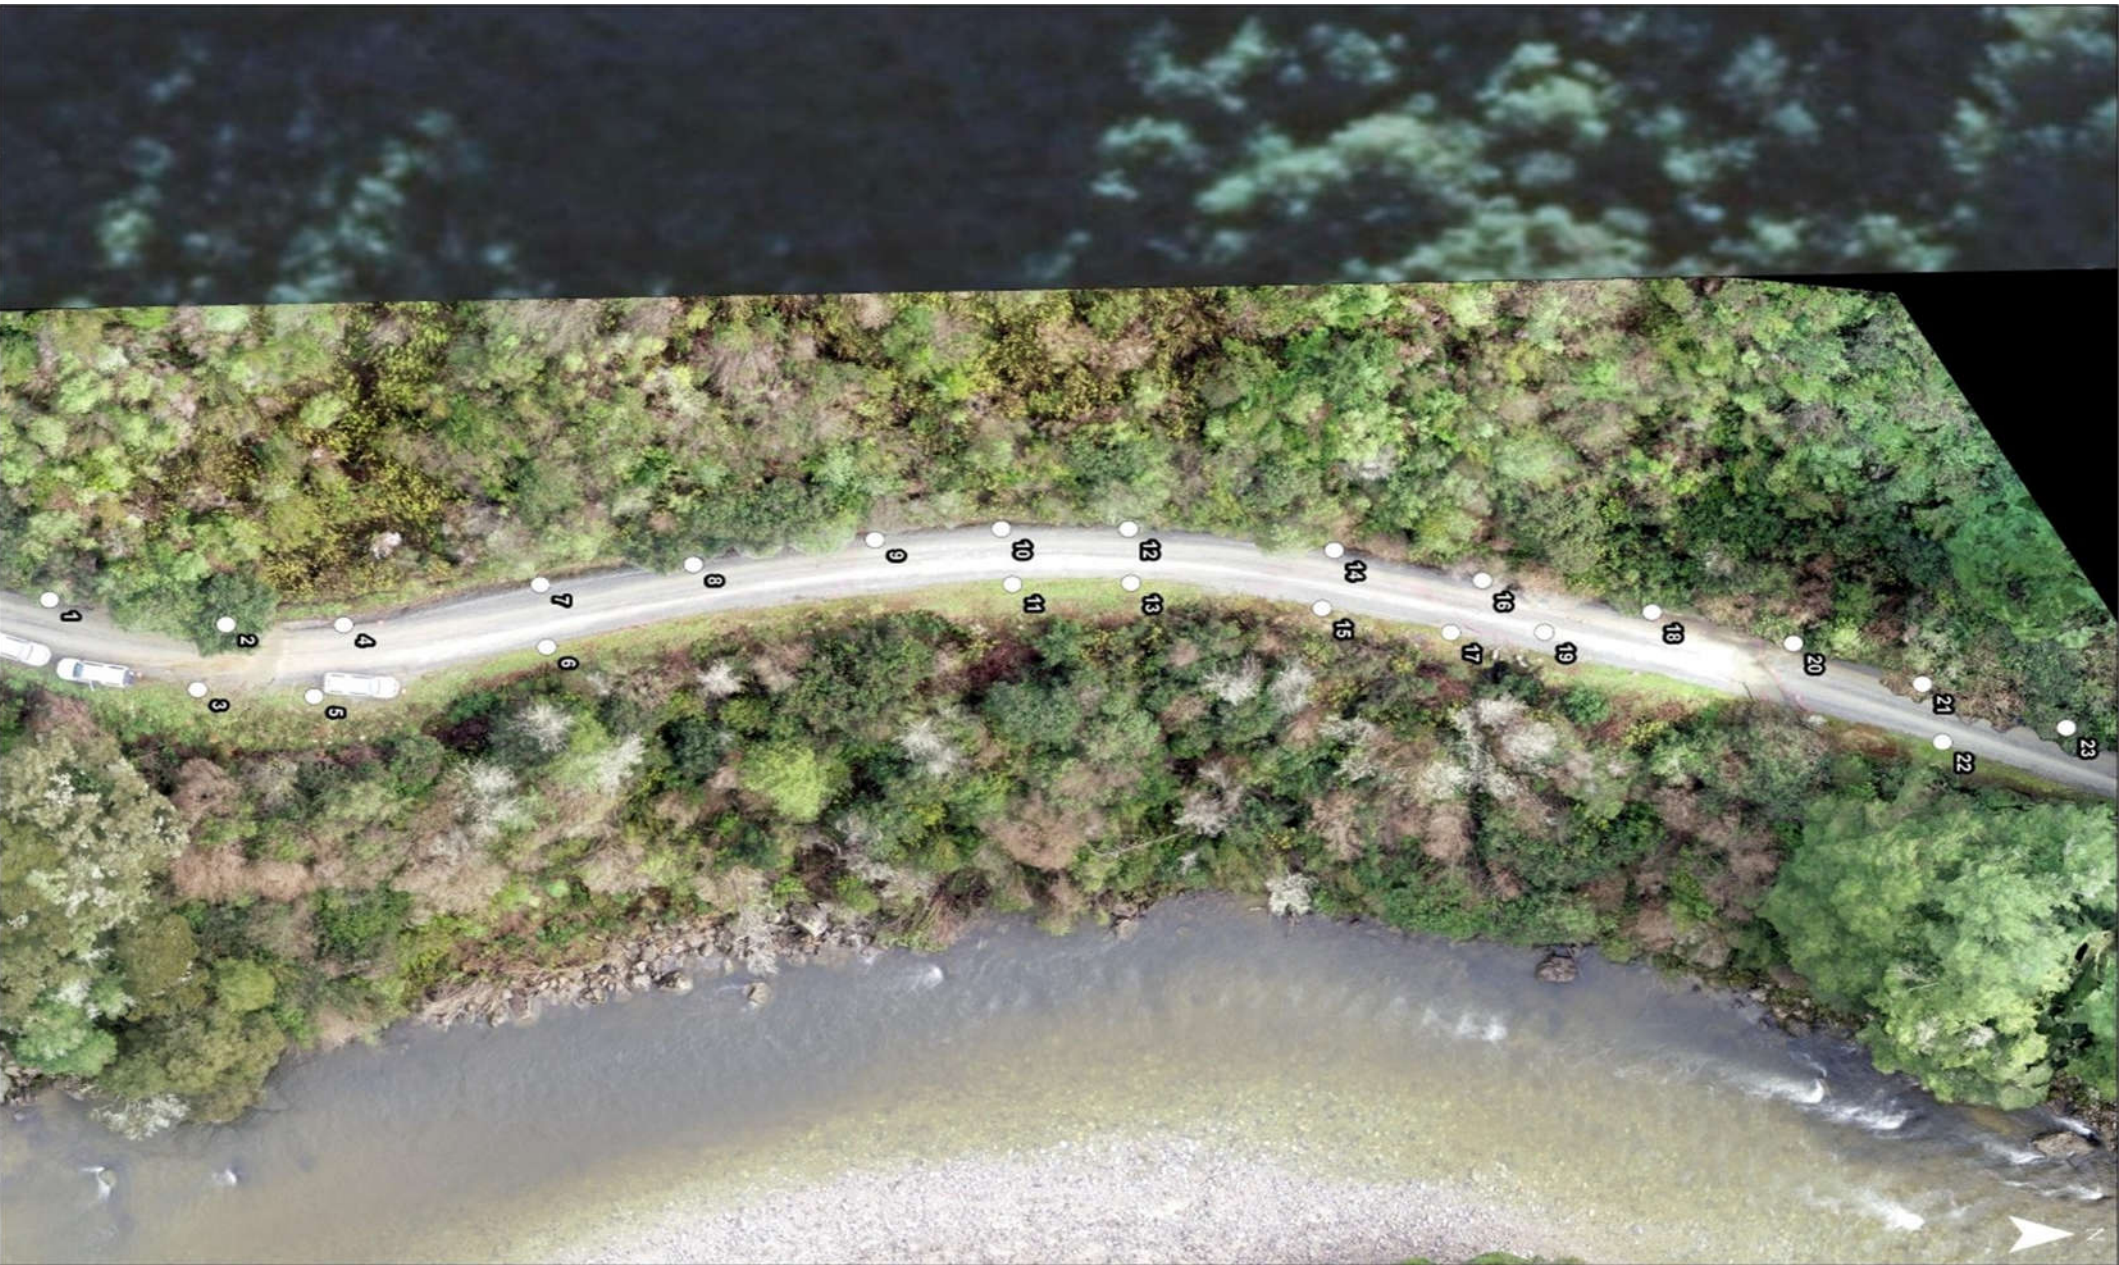
Date of Survey	Movement north/south in the 2 weeks between	Movement east/west in the 2 weeks between Heading	Vertical change in the 2 weeks between	Comment
16 August	Initial Survey	Initial Survey	Initial Survey	Movement aggregated across all pins
30 August	Range + 15 to - 16 mm	Range 144 to 247 mm towards river, typical 180mm,	Range -63 to -153 mm, typical 80 mm	Pins on outside edge at culvert moved and dropped further than others
12 September	Range 0 to -7 mm	Range -4 to +11 mm, most < 5mm, towards river	Range -1 to -8 mm, most < 4 mm	
26 September	Range 0 to 9 mm	Range - 6 to + 8 mm	Range - 3 to + 2 mm	Pin 16 has been knocked by a vehicle – result not included

Tasman Gowland have advised that the accuracy of the monitoring survey that is being undertaken is +/- 5 mm in X, Y and Z directions.
