Wastewater Inflow and Infiltration

Tools in the toolbox

Distributed Temperature Sensing and Manhole Level Sensors

Tasman District Council

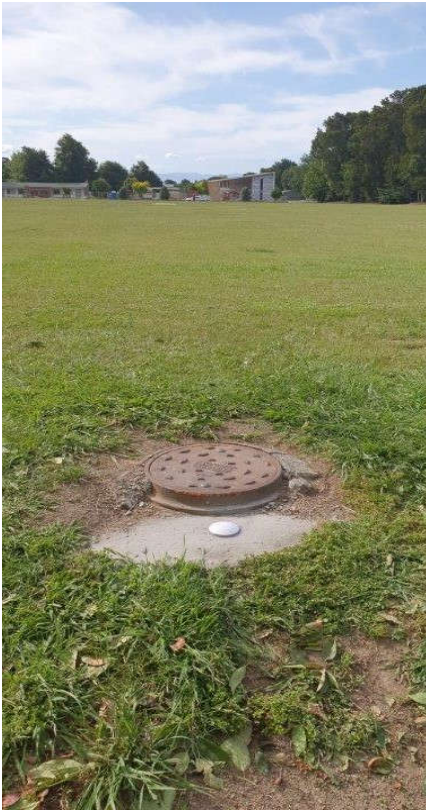
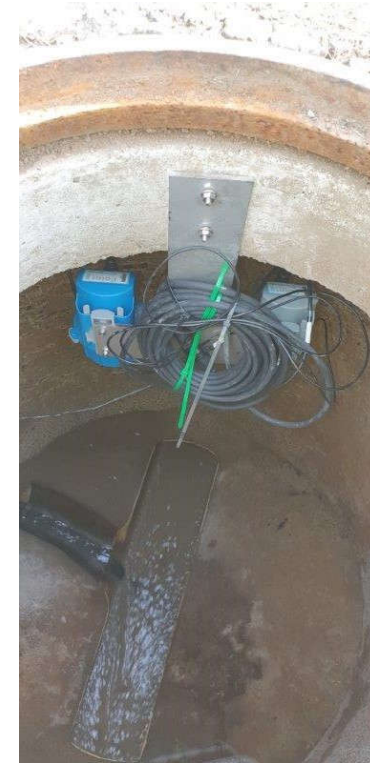
Manhole Level Sensing

- Highlighting trends. Initially looking for large anomalies
- Allowing cost effective monitoring of sub-networks
- Selection of sub networks where DTS deployment would be beneficial
- Provide on-going monitoring to ensure that gains made are not lost over time.

- Correct manhole selection is important.
- Timely monitoring of data

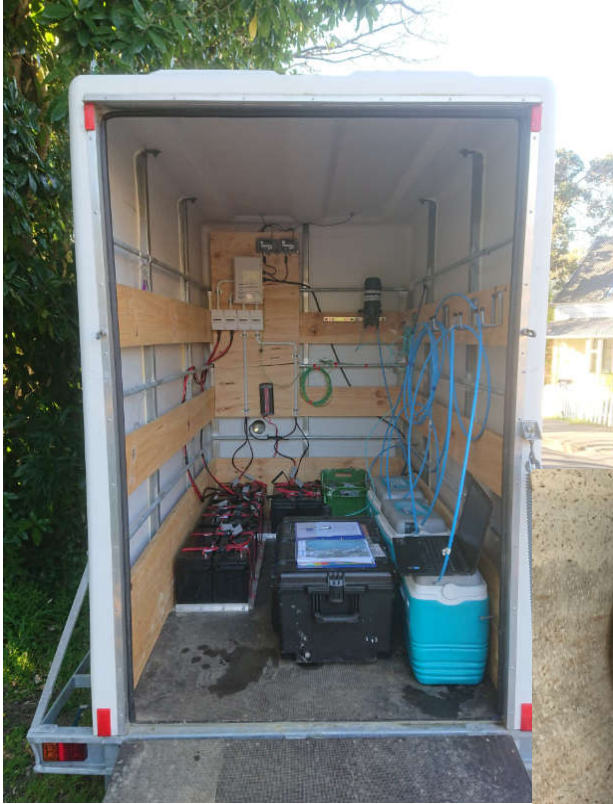
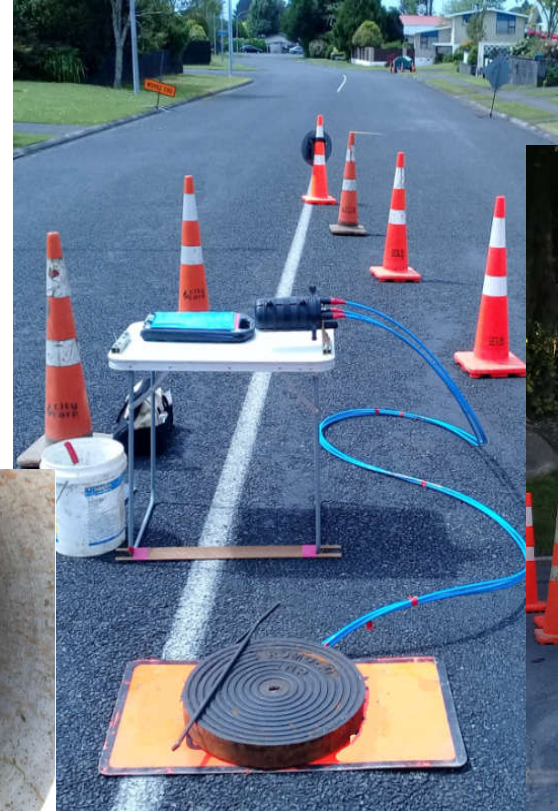
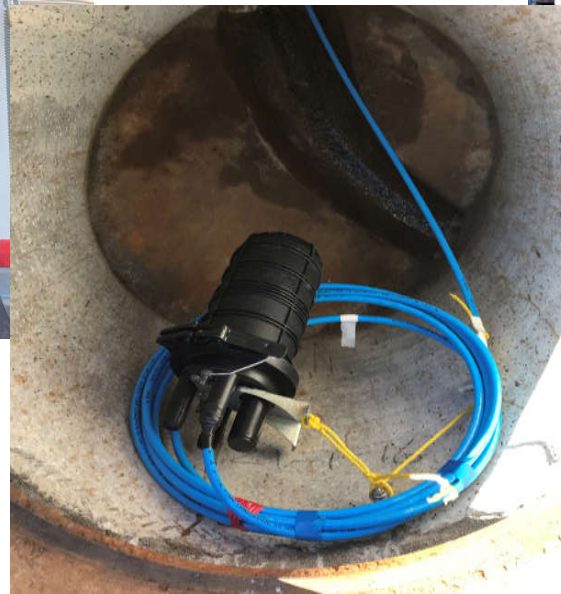
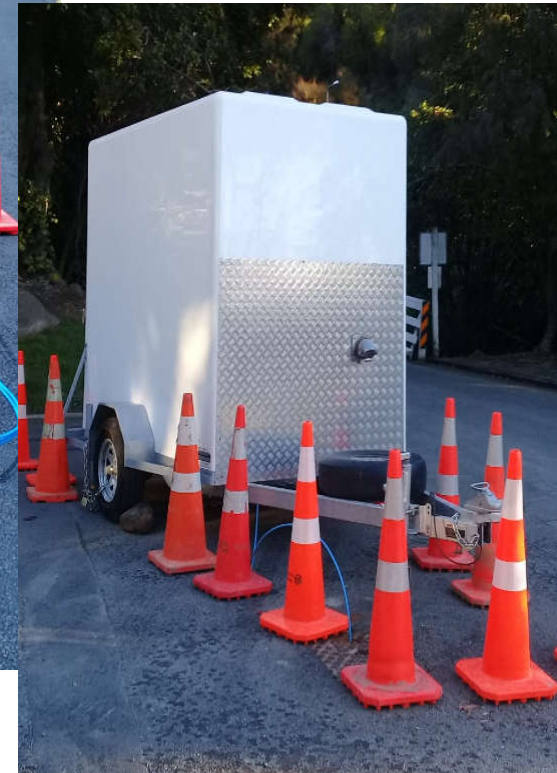
Distributed Temperature Sensing

Source	1D/977
Location on DTS	977 m
Asset	Manhole WWT-14659
Address	11B Coppins Place
Analysis	Temperature differential below 0°C during low wastewater flows in the early hours of the morning. This is most likely caused by continuous infiltration of cool ground water that is observable during times of low wastewater flow but masked during times of medium to high wastewater flow.
Recommendation	Inspection of MH checking for signs of deterioration and infiltration. Lateral only inspection of nearby connected properties (11B and 12A Coppins Place) looking for deterioration and infiltration.
Note	The private laterals for 11B and 12A Coppins Place are asbestos cement installed in 1980.

Source	1E/1138
Location on DTS	1138 m
Asset	Pipe WWT-36291 DN150, 38.12m, asbestos cement, 1980.
Address	4 Coppins Place
Analysis	Temperature differential below 0°C during low wastewater flows in the early hours of the morning. This is most likely caused by continuous infiltration of cool ground water, that is observed during times of low wastewater flow, but masked during times of medium to high wastewater flow.
Recommendation	CCTV inspection of pipe checking for signs of deterioration and infiltration.

Green ticks in the graph indicate temperature drops in the early hours of the morning which was only observed on dry days. Red crosses indicate mornings where there were not significant temperature differentials in the morning.
