Landslip Stabilisation - Turei Hill, Kawakawa Bay

*Mark Faulkner, Manager/Partner
and
Greg Saunders, Projects Team Manager, Partner*

*Opus International Consultants, Manukau
Corner of Davies Avenue and Putney Way
PO Box 76 725 Manukau City*

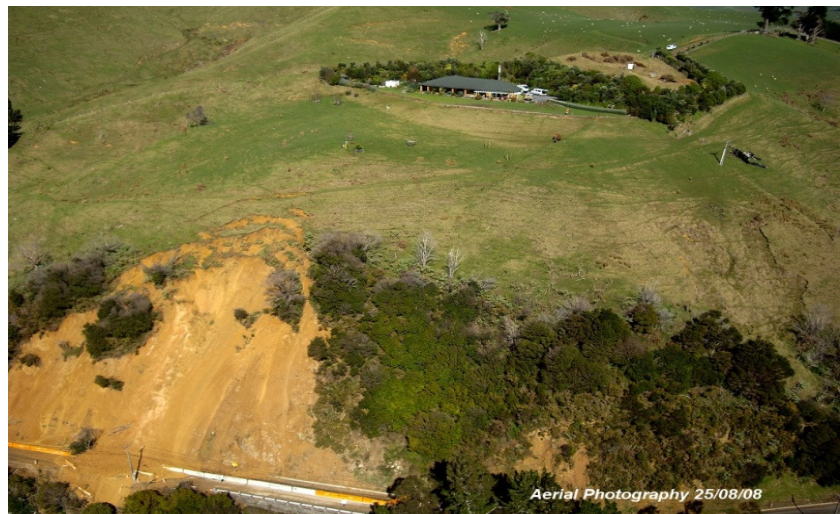
Figure 1: Road Slip Face August 2008

This was removed by the Council's road maintenance contractor but highlighted a concern with respect to the remainder of the slope stability. The road and slope were subjected to a geotechnical assessment on 6 August 2008 to gauge the extent of the problem and Council were advised that a potential major landslip may occur as there were significant cracks appearing in the slip scarp some 40 to 50m above the road.

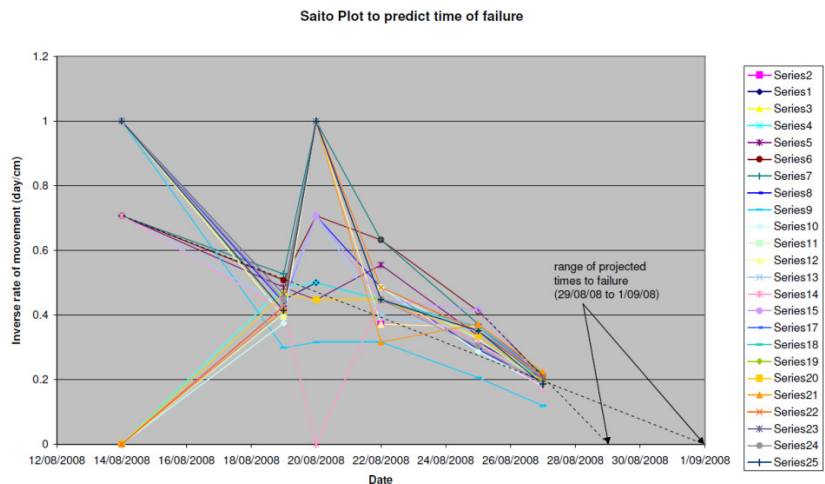
Within a few days Saito plots of the landslide movement produced by Tonkin and Taylor Ltd for the EQC indicated acceleration of the landslide movement. These plot the inverse rate of movement versus time (refer to Figure 2) and at this point they concluded:

“If the data and empirical interpretation are correct and the slope continues to accelerate as of yesterday’s readings, then the plot indicates that failure is likely within the next 24 hours to 4 days”.

Figure 2: Saito Plot

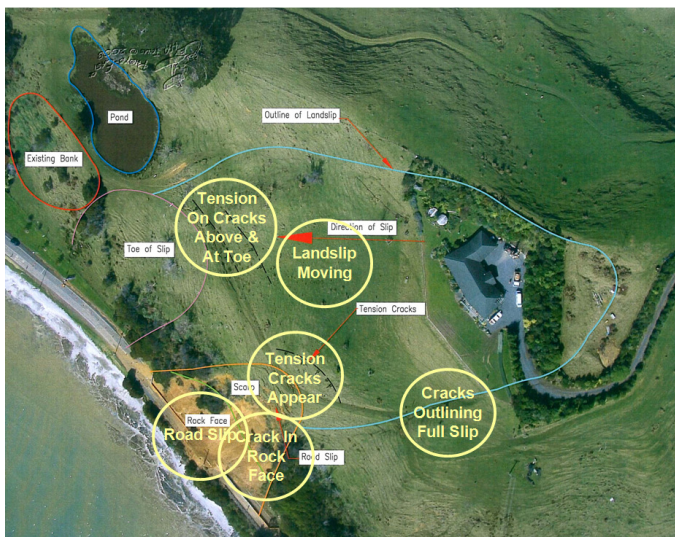
Figure 4: Plan View of Landslip and Features

A public meeting was held at Kawakawa Bay on 27 August 2008 to outline the size, nature and scale of the landslip which had subsequently been determined, but from road level was not immediately evident and lead to scepticism about the seriousness of the event. The landslip covered an area greater than two hectares and the head scarp encircled the adjacent landowner's house as depicted in Figure 4, which was gradually moving down slope, severing the utility service connections. The house moved vertically in excess of a metre before it was eventually demolished.

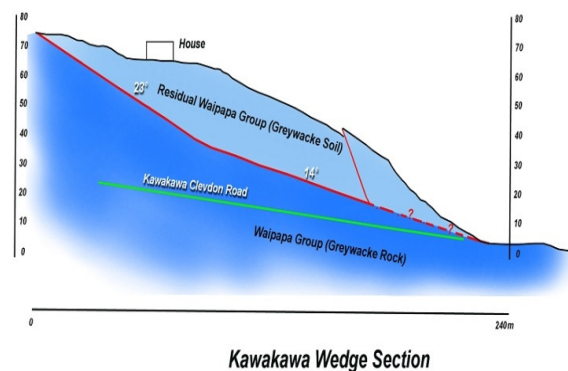
Figure 5: Stylised Cross Section of Landslip

A second public meeting was held at Kawakawa Bay on 10 September 2008 to reinforce the public danger posed by the landslide involving the mobilisation of some 300,000 to 500,000m³ of material. Further slip material had been deposited on the Clevedon–Kawakawa Road over the previous two weeks. This had not been able to be removed by the Council’s road maintenance contractor due to safety concerns for their personnel.

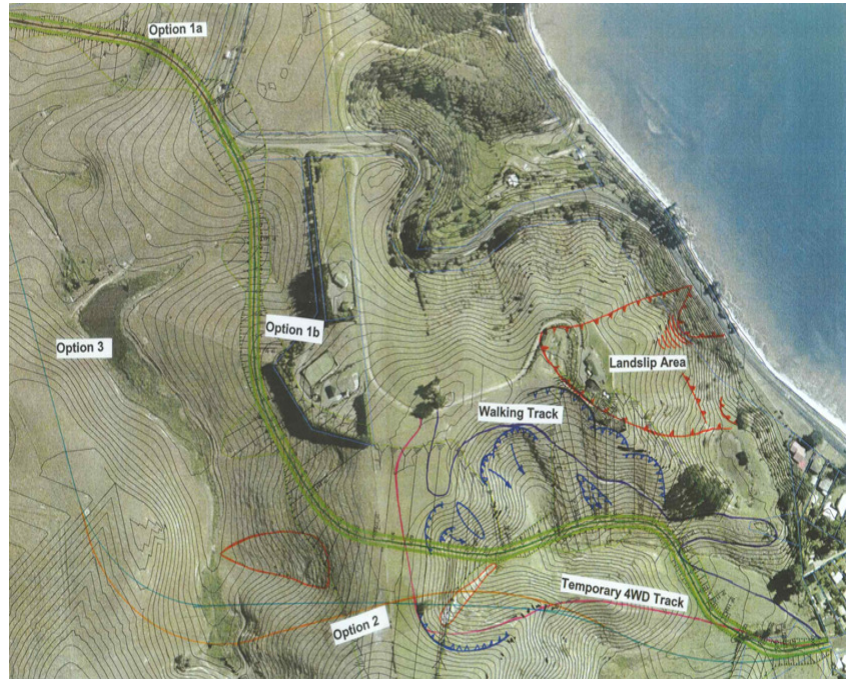
As a consequence all of the above were implemented with varying degrees of use and patronage. The alternative access provisions established are detailed in Figures 6 and 7.

The temporary walking track and four wheel drive access track were constructed and operational on 2 September 2008 and 8 September 2008 respectively.

Figure 6: Realignment Options, Walking Track and Four Wheel Drive Route

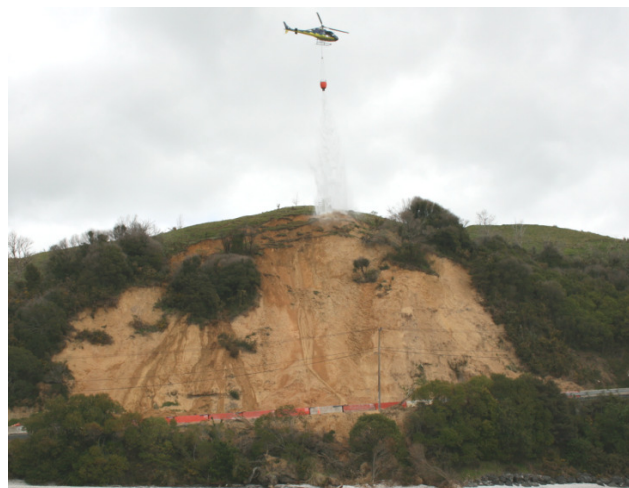
Figure 8: Sluicing in Progress

Opus and Tonkin and Taylor Ltd investigated options for the removal of the loose surface slip material perched above the road and off to the side of the main landslip to allow single lane access to be reinstated if the rate of movement continued to reduce. Aerial sluicing utilising a helicopter and monsoon bucket presented the safest option due to the height and steepness of the adjacent slope.

Sluicing was undertaken on 16 September 2008. The material dislodged was contained within a polythene wrapped concrete median barrier bund to prevent a discharge of the water borne sediments into the adjacent coastal marine area on the down slope side of the road.

Clean up work began using vacuum trucks and took six days to complete and a further geotechnical assessment was undertaken. This assessment confirmed that the slope had gained some degree of stability. Temporary traffic signals were installed to allow restricted one way traffic past the base road slip while the slope stability was monitored with a view to re-opening the road at the earliest opportunity.

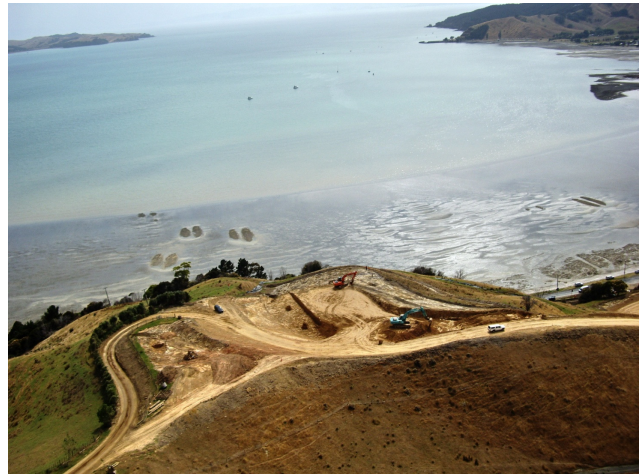
Figure 10: Earthworks Commencement January 2009

The first activity undertaken was the demolition of the adjacent landowner's house and installation of sediment and erosion control measures. Earthworks, by sub-contractor Hopper Construction Ltd began in earnest on 19 January 2009 (refer to Figure 10) in parallel with discussions with the Auckland Regional Council (ARC) regarding the preparation of a resource consent application for the works. This was to be sought retrospectively as the works were being undertaken under the emergency provisions of the Resource Management Act.

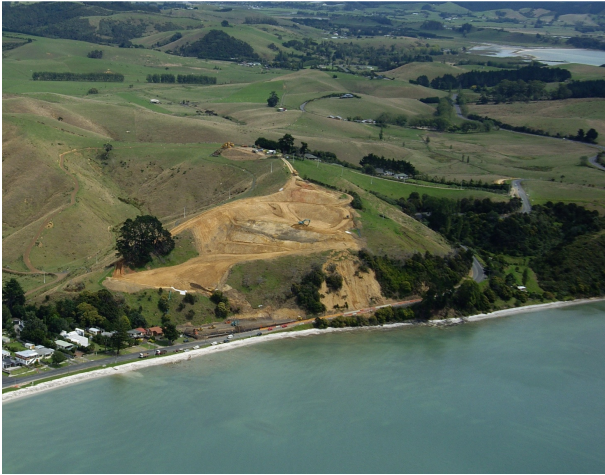
Figure 11: Earthworks and Bored Drainage March 2009

- Fractured rock that made drilling the horizontal bored drains and ground anchors a slow and laborious operation.
- Constructability issues around the installation of the ground anchors that resulted in the re-design of the final contoured shape of the landslip. This increased the volume of earthworks removed to 105,000m³ but decreased the quantity of anchors required to 45, resulting in an overall cost reduction.

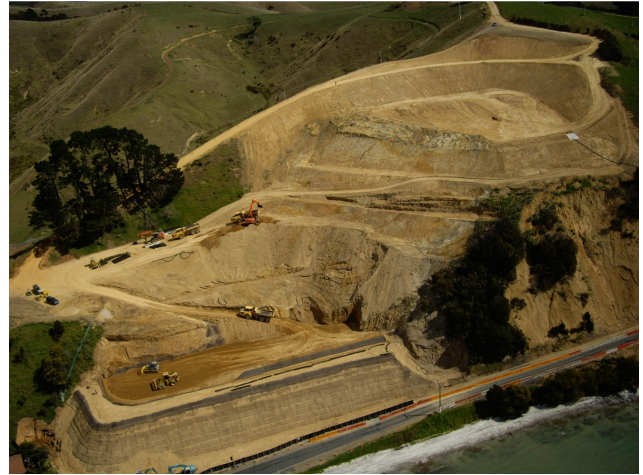
Figure 12: Toe Buttress Under Construction April 2009

- Poor ground conditions at the base of the buttress fill which required the re-design of the shear key and construction of a permanent pump station to dewater the toe of the fill.

Despite the above challenges the bulk earthworks to construct the buttress fill embankment, and the disposal of the excess material to the landfill site contained within the adjacent landowner's property were completed by the end of June 2009, (including the 39,000m³ of additional material removed from the top of the landslip as a result of the re-design associated with constructability of the ground anchors).

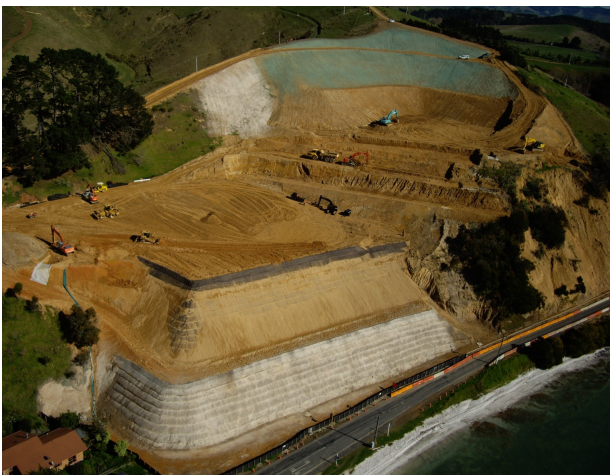
Figure 13: Toe Buttress Completion May 2009

The surface of the re-contoured slope was stabilised with straw mulch and hydro-seeded to prevent sediment runoff over the 2009 winter. Site progress is illustrated in Figures 11, 12 and 13. The majority of the horizontal bored drains were also installed by the end of June 2009 and this, in conjunction with the completion of the earthworks and the toe buttress fill, restored the factor of safety and minimised the risk of further movement occurring and hence the residents in the properties below the landslip were permitted to remain in residence. Installation of the reduced number of ground anchors commenced in July 2009 (refer to Figure 14) and were substantially completed by December 2009, two months later than anticipated due to the anchor supply delay experienced by the contractor.

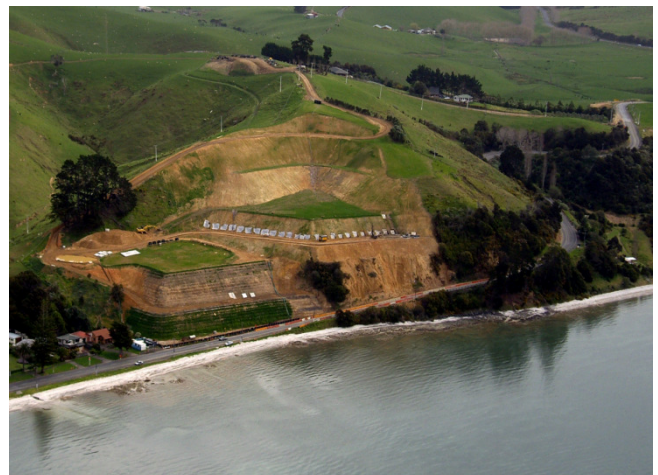
Figure 14: Rock Anchors Being Installed August 2009

- Changes to the face plate design for the ground anchors with the inclusion of a greater concentration of shear reinforcement around the central area of the concrete face plate to counter the high punching shear loads transferred through the steel bearing plates for the anchor heads.

- Supply issues relating to the ground anchors which were sourced from Korea.
- Clashes between the ground anchors and the horizontal bored drains.
- Permeability of the ground strata that required the pre-grouting of the anchor holes.
