Seasonal Surfacing

Fostering Collaboration: Whanaungatanga in transport asset management

H Higgins Seasonal Surfacing Process

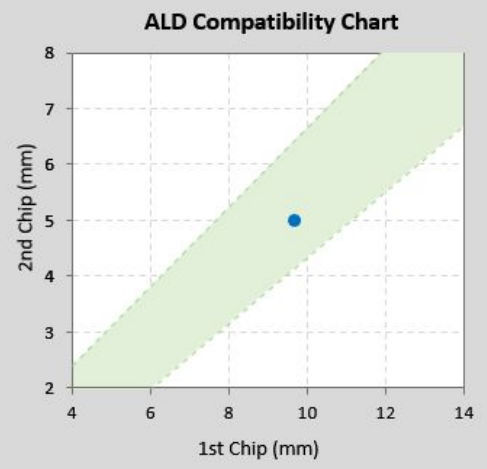
ALD Compatibility Chart

ALD Compatibility Check: PASS

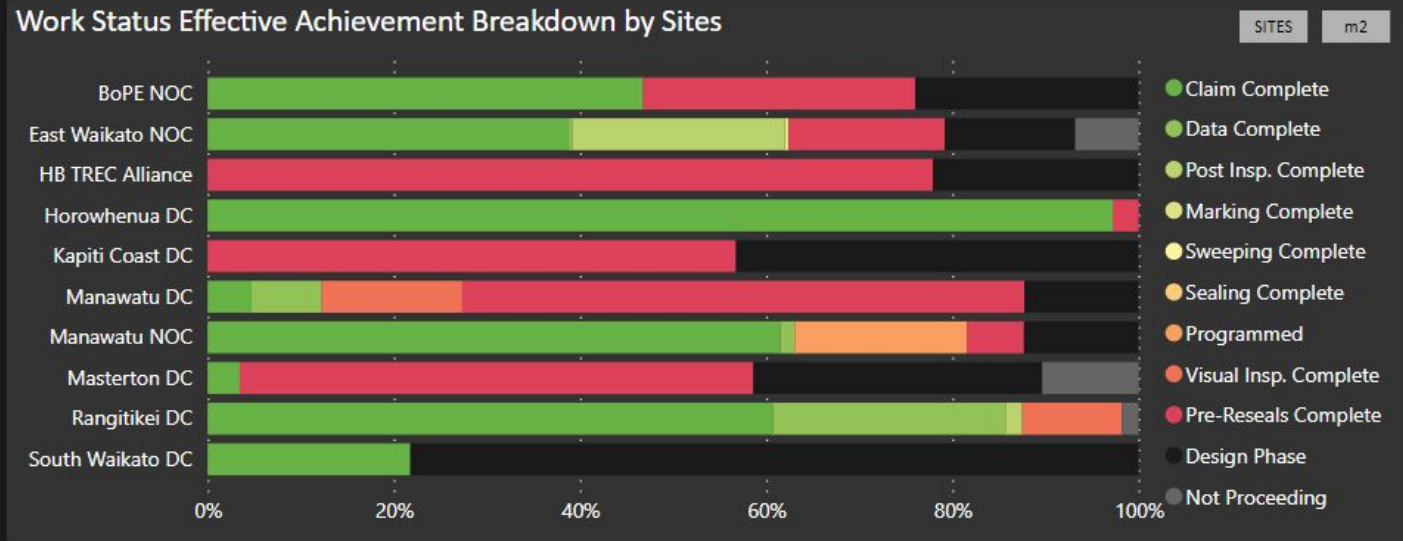
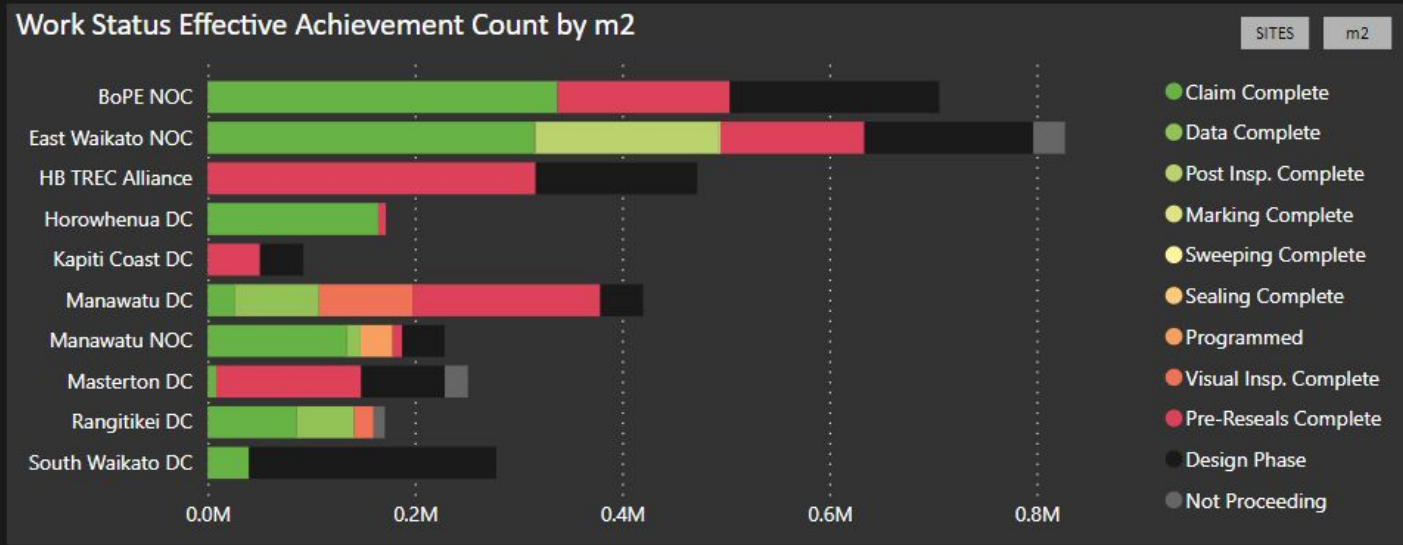
WORK STATUS

Work Status Achievement

- Claim Complete **56 %**
- Data Complete **34.9 %**
- Post Insp. Complete **48.2 %**
- Marking Complete **48.2 %**
- Sweeping Complete **48.2 %**
- Sealing Complete **48.2 %**
- Programmed **40.2 %**
- Vis. Insp. Complete **55.2 %**
- Pre-Reseals Complete **78.7 %**
- Validated **100 %**
- Proceeded **2.3 %**

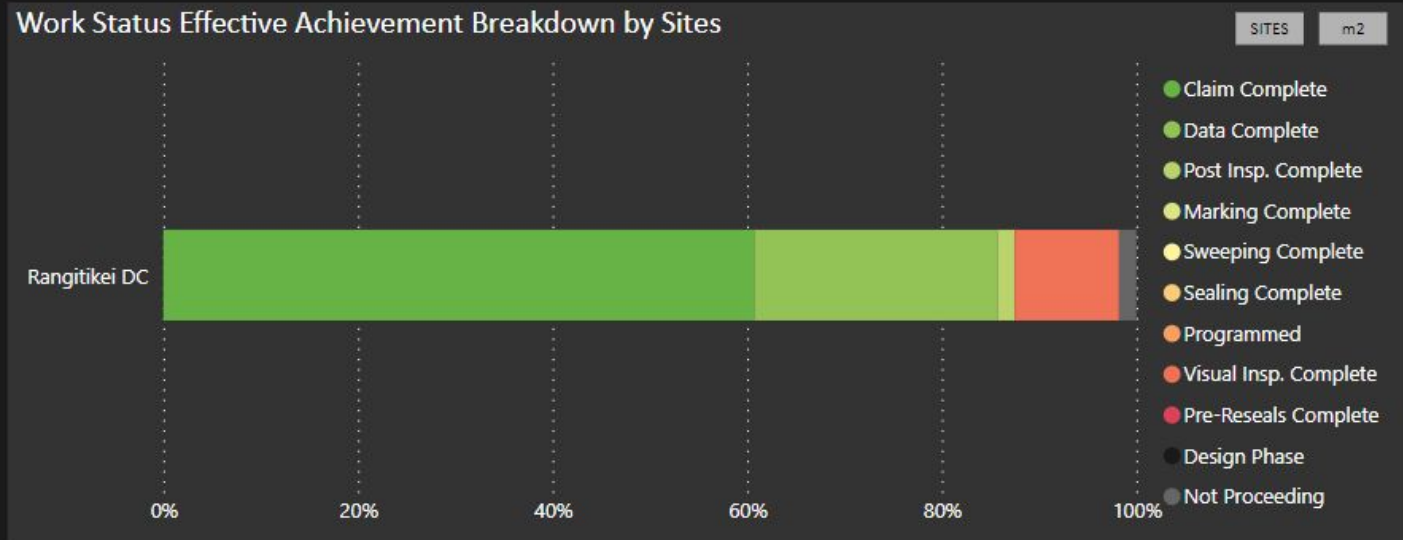
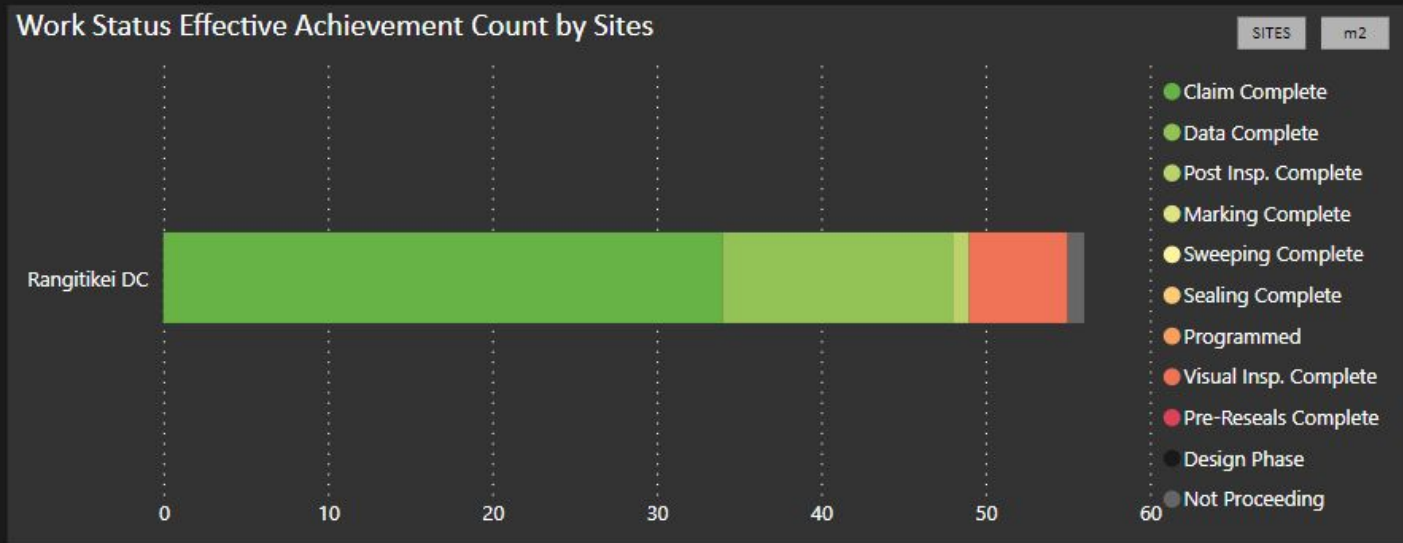
WORK STATUS: WHAT GOOD LOOKS LIKE

Work Status Achievement

Claim Complete	61.8 %
Data Complete	78.2 %
Post Insp. Complete	81.8 %
Marking Complete	81.8 %
Sweeping Complete	81.8 %
Sealing Complete	81.8 %
Programmed	61.8 %
Vis. Insp. Complete	96.4 %
Pre-Reseals Complete	100 %
Validated	100 %
Proceeded	3.5 %
