# FLOODED CLASSROOMS INSPIRING ENVIRONMENTAL EDUCATION

*Dever-Tod K (GHD Ltd)*

## **Abstract**

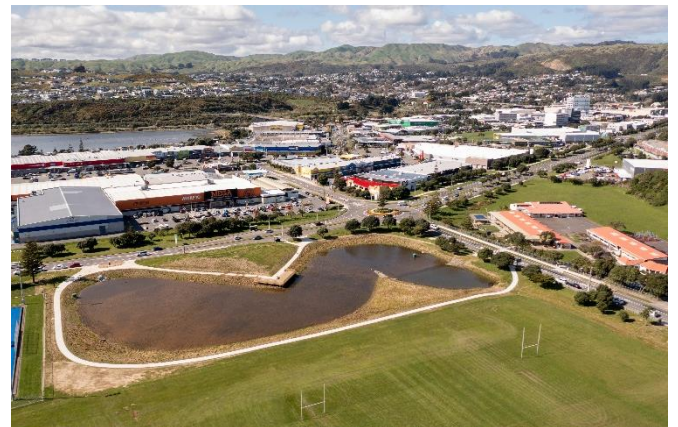
*Figure 1. Te Kukuwai o Toa, the new urban wetland in central Porirua (captured by Mark Tantrum Photography).*

The new urban wetland in Elsdon Park treats the most polluted 'first flush' of stormwater from a 42 hectare urban catchment carried by the Urukahika Stream (piped). The wetland provides water quality treatment, attenuation of frequent rainfall events and flood storage capacity during infrequent rainfall events.

The wetland is designed to function in various flow conditions and can receive flows up to 300 litres per second. This flow rate limits peak velocity in the wetland to protect treatment processes. Flows that exceed this are directed into the bypass pipeline via an inlet diversion manhole.

The wetland inlet diversion conveys flows for treatment into the forebay through a buried inlet pipe. A sunken manhole adjacent to the diversion manhole provides preferential capture of coarse gravel and dissipates energy before flows are discharged to the wetland inlet pipe.

The permanent water level within the wetland is enabled by using a geosynthetic clay liner (GCL), which extends across the full footprint of the wetland. The wetland level is controlled by a weir in the wetland outlet manhole, connected to the wetland outlet pool by a submerged pipe.

Flows that exceed the wetland discharge rate, cause the wetland water level to rise by up to 350 mm, engaging the surplus event detention volume (EDV of 2,870 m<sup>3</sup>). Infrequent flood storage is engaged by the flood surcharge manhole which allows the wetland to fill further by backwatering. This enables an additional 7,900 m<sup>3</sup> of storage above the event detention level (EDL). This flood storage volume will draw down via the surcharge manhole and wetland outlet as rainfall decreases to the permanent water level, typically over a 24-hr period.

The wetland basin is heavily vegetated to support a variety of treatment processes, including a complex mix of physical, biological, and chemical processes to treat stormwater before it reaches the harbour. Over 35,000 locally eco-sourced aquatic, riparian and terrestrial native species were planted across the wetland footprint, 20,000 of which were supplied by local community nursery Te Rito. The wetland uses banded bathymetry to enforce a uniform velocity across the wetland's cross-sectional area. This increases the contact between stormwater and vegetation and prevents the formation of stagnant zones or short circuiting. This integration of natural systems (by way of vegetation and biota) necessitates a program of proactive maintenance rather than solely relying on reactive maintenance.

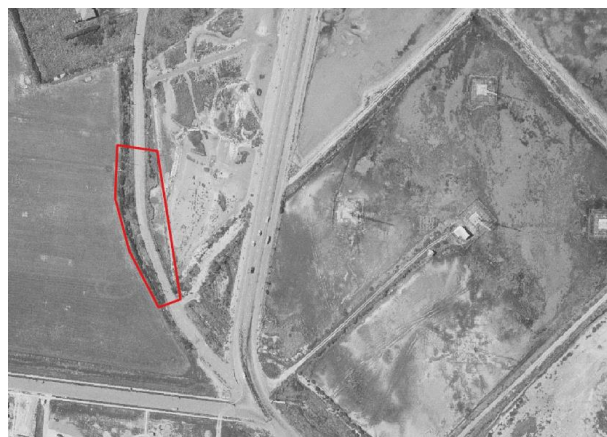
Figure 3. Historic road section discovered shown in 1959 aerial SN1530 K 1 CC-30 BY (Dodd, 2022).

Excavation of the wetland basin further revealed an historic road formation, determined to be the original alignment of Titahi Bay Road, abandoned following the creation of Elsdon Park in 1963 (Dodd, 2022). An immediate stop works order was issued whilst a Section 45 approved archaeologist together with iwi representatives investigated the discovery. Excavation in the proximity of the historic road was stopped for five weeks in total. The discovery, made possible by the prioritisation of cautious excavation over construction efficiency, enabled the iwi a glimpse at the stories told by kaumātua of the historic road. The discovery was shared throughout the community and enabled them to connect with the history of the land.
