Te Pahu Road Bridge Pier Stabilisation

TE PAHU ROAD (RP 17236) BRIDGE PILE DEFECT REMEDIAL INVESTIGATIONS

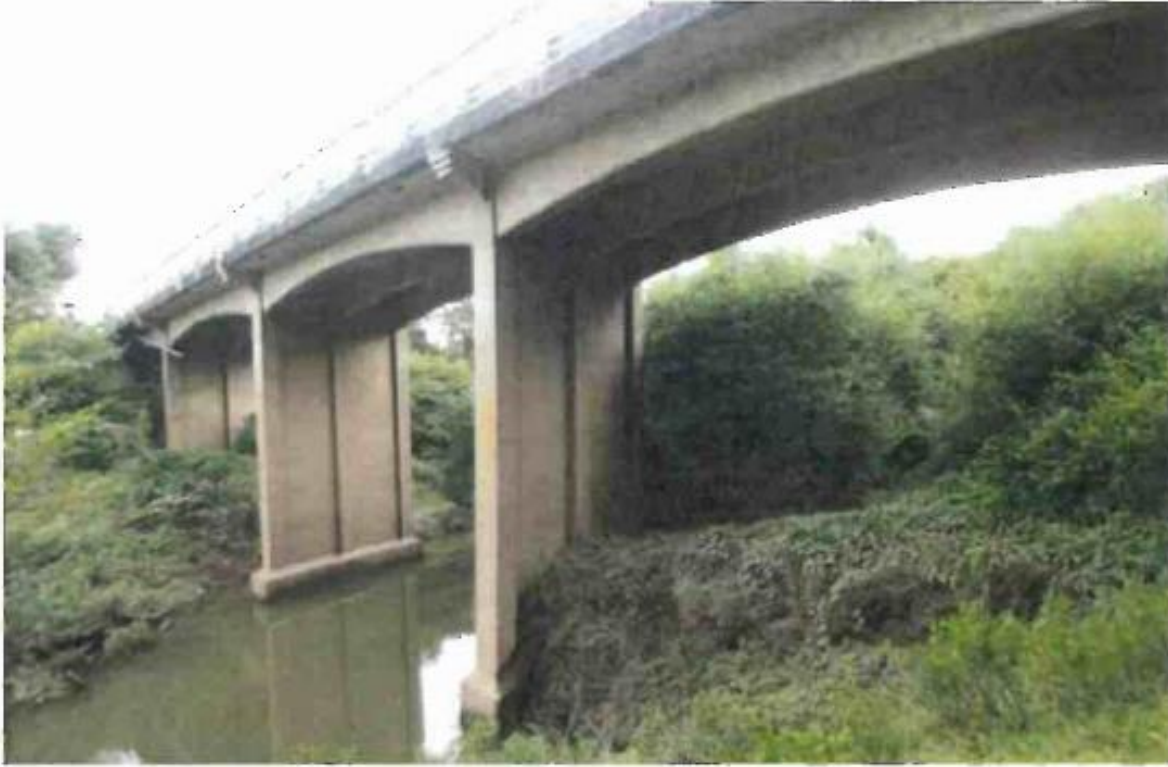
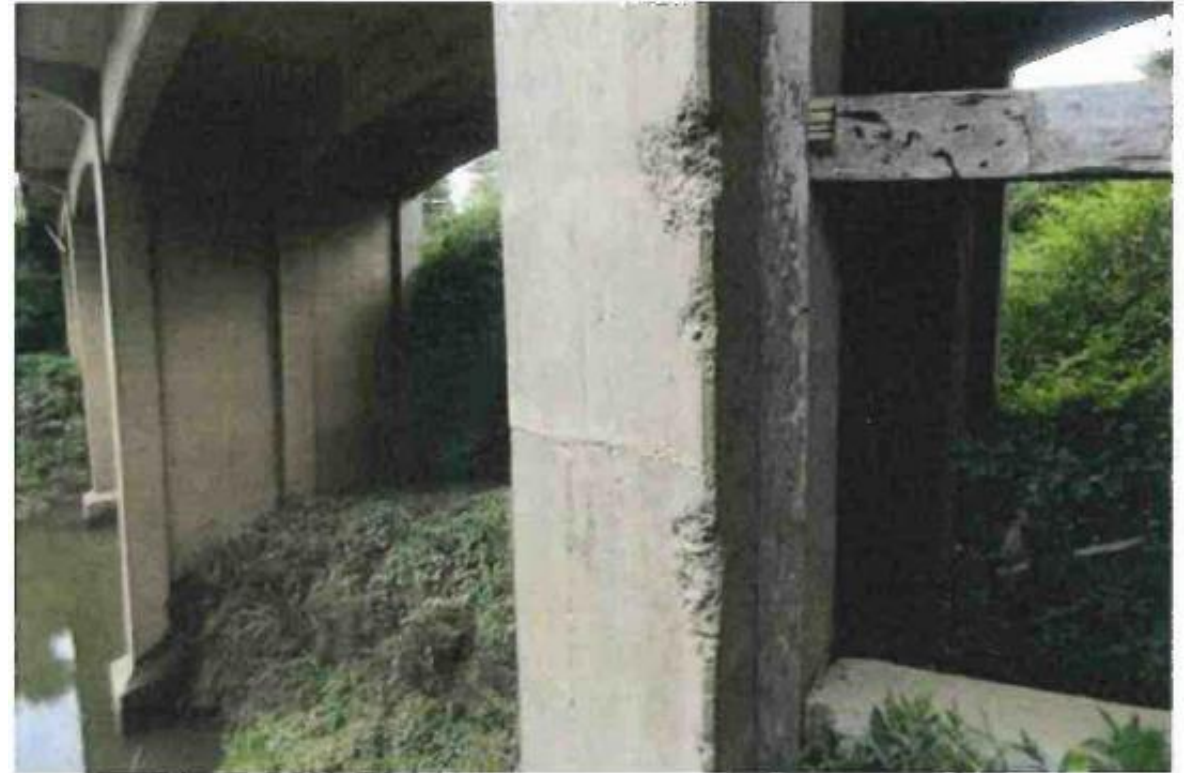
Photos from 2013, Access wasn't great.

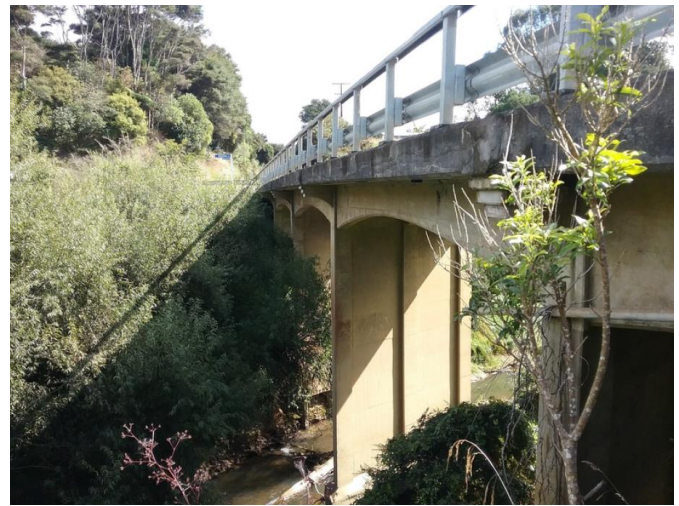
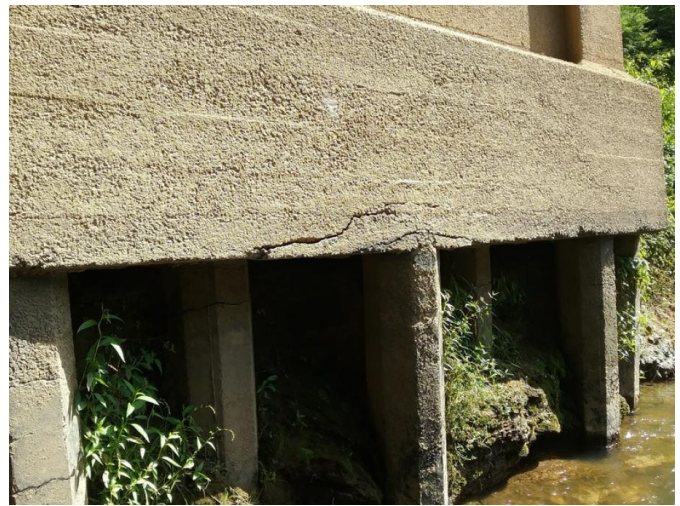
Large horizontal cracks to most piles of Pier D up to 5mm, also spall to lower pier above pile. Small shallow spalls to edge of Pier C & E. Diagonal crack to Pier B at A face LHS up to 0.4mm, also CJ cracks at top of pier walls. Piles at piers C & D are exposed up to 1.5m.

Comments and recommendations for maintenance/repairs		
Suggested remedial work	Priority (H/M/L)	Estimated cost
Break out & repair all spalls to cantilever.	M	\$10,000
Cracks to piles of Pier D are below water level. Cracks noted in last inspection however appear relatively recent. Investigate cause of cracks and develop a repair solution.	H	\$25,000
Remove detritus & vegetation from kerbs.	H	\$500

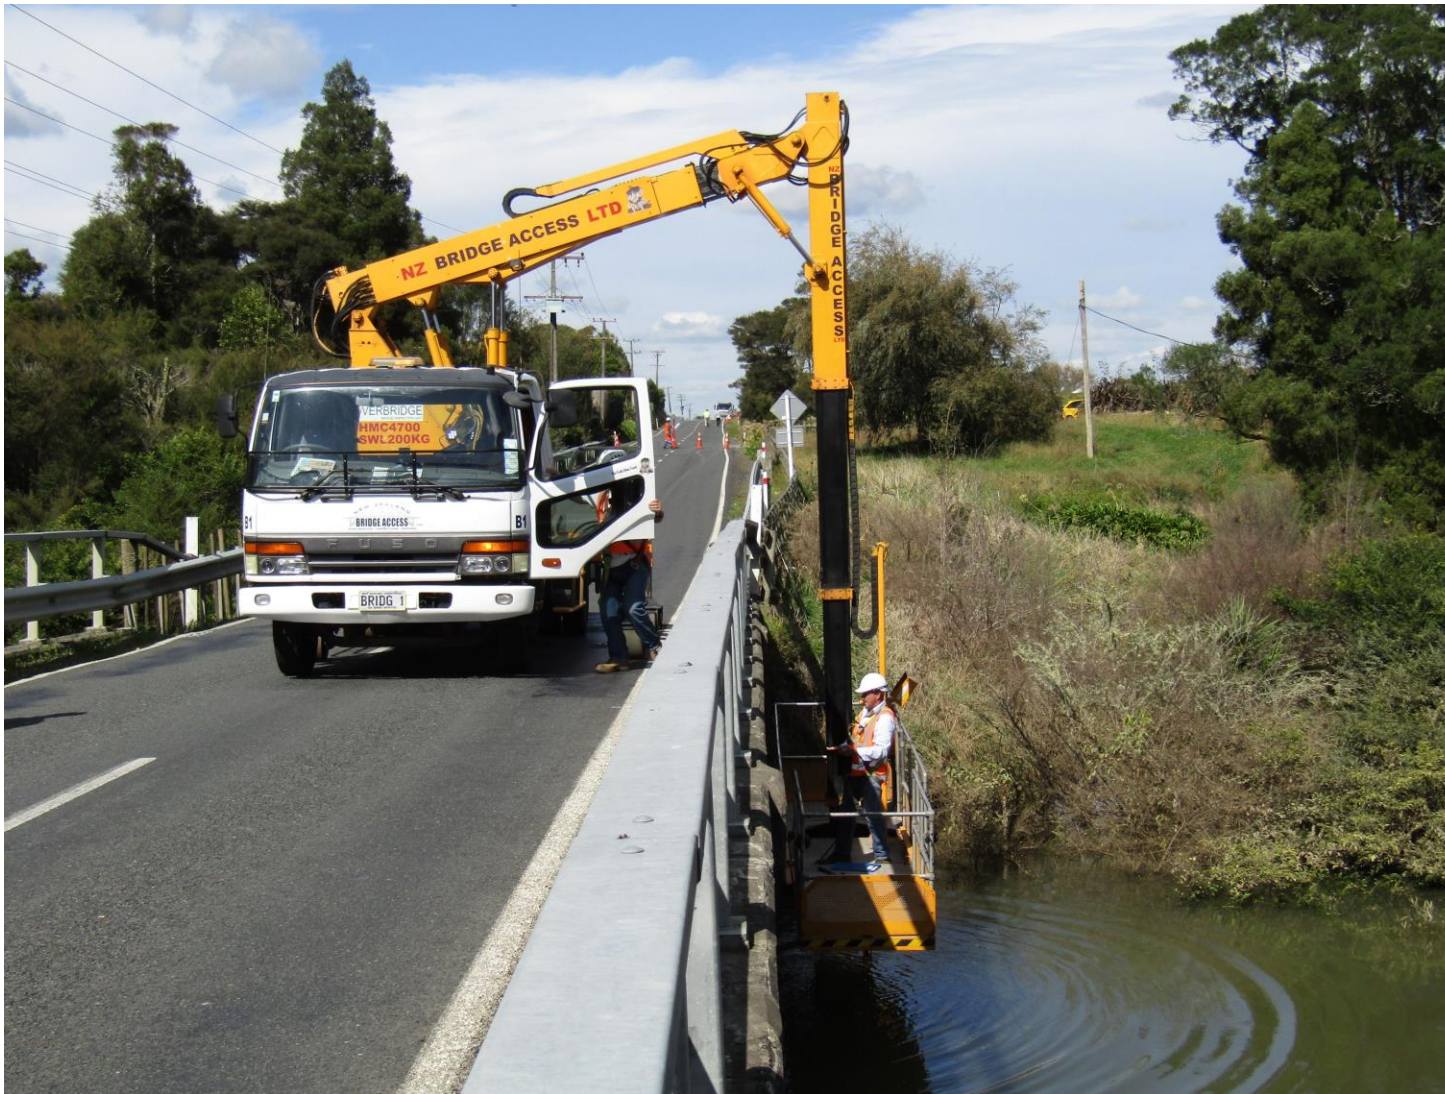
Photos from 2017

.... found cracks at the top of the pier too (hinging)

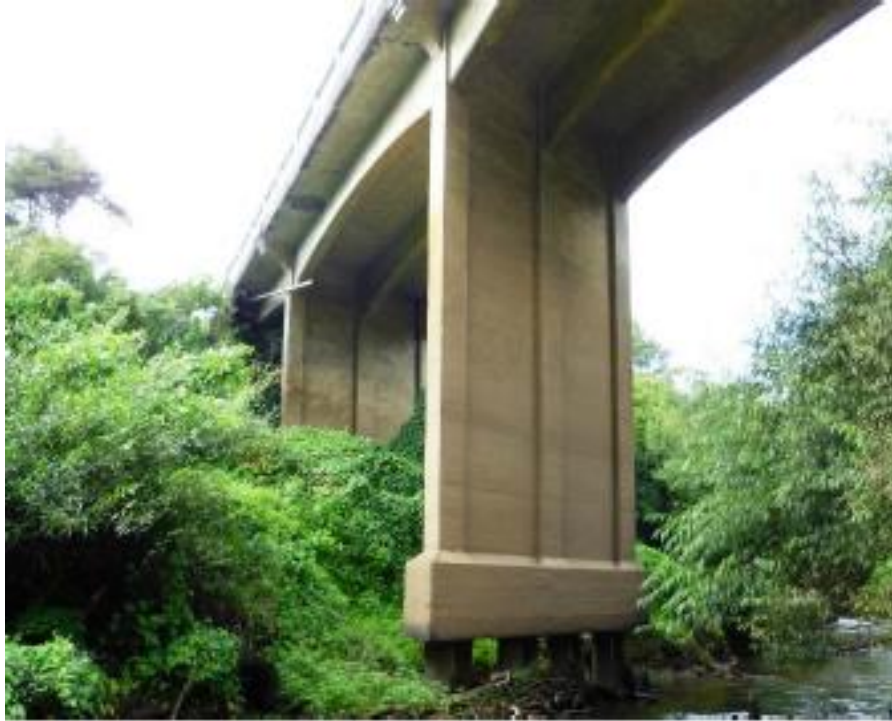
15 February 2017

And water levels were highly variable,
shame we didn't use a boat instead of the
Bridge Inspection Unit....

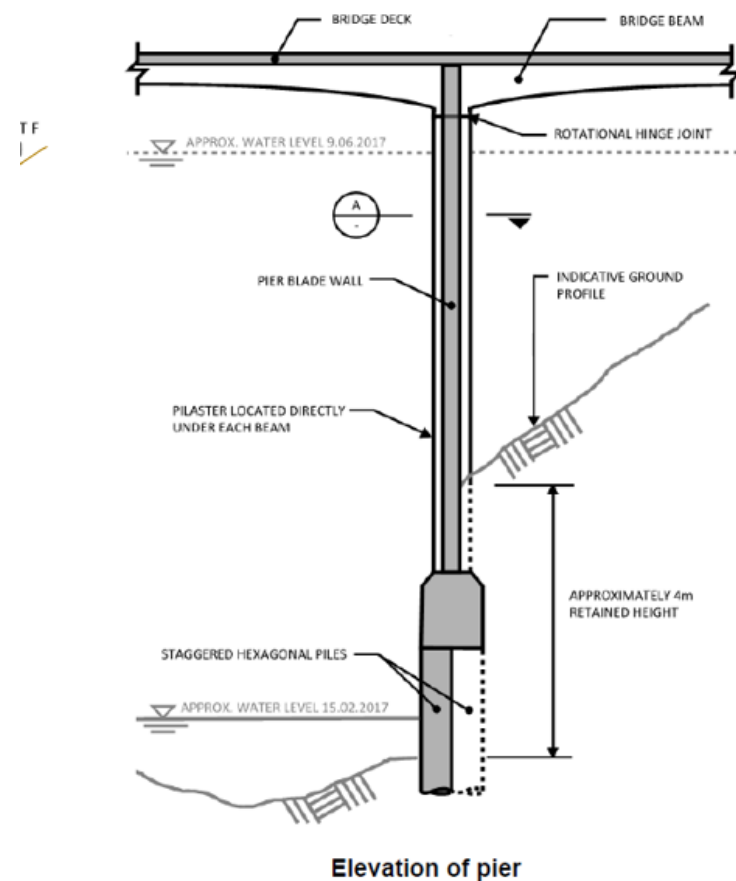
Pier D was 300mm off vertical

Pier D was built as a pier but now expected to do the job of a retaining wall.

The lowering bed level was worsening.

The ground being retained was getting flooded for many days several times a year.

The ground being retained was poor quality and slowing slipping.

Good ground was a long way down.

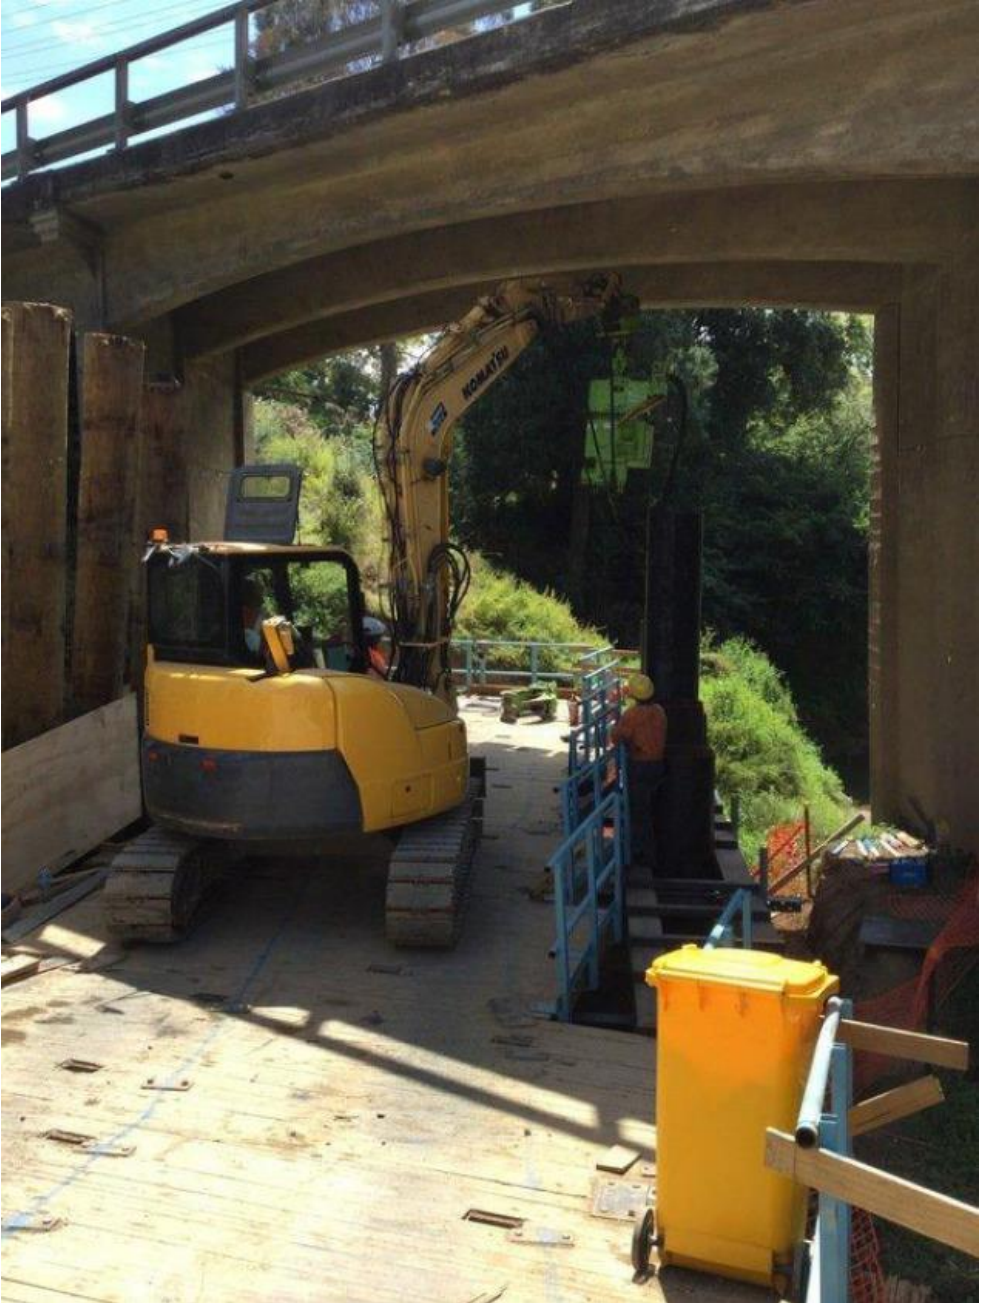
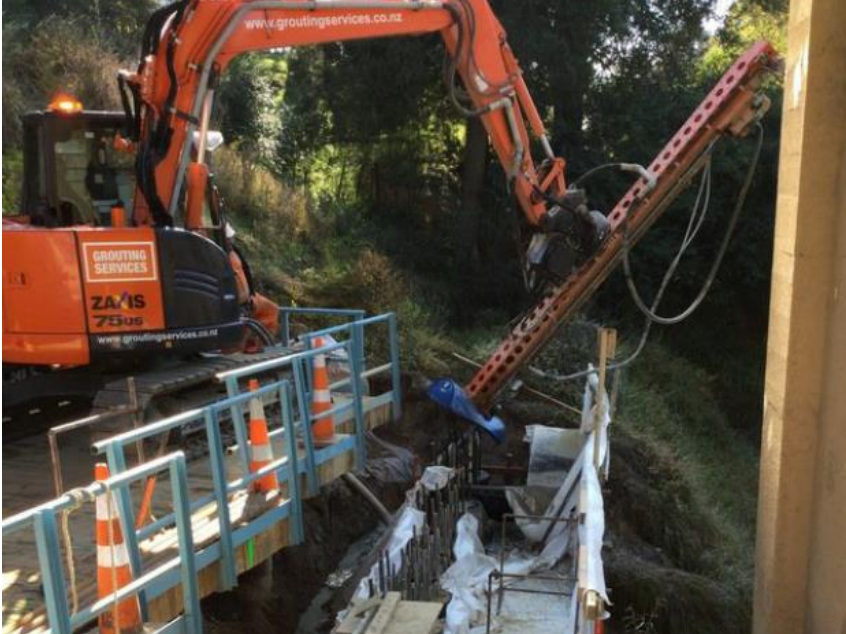
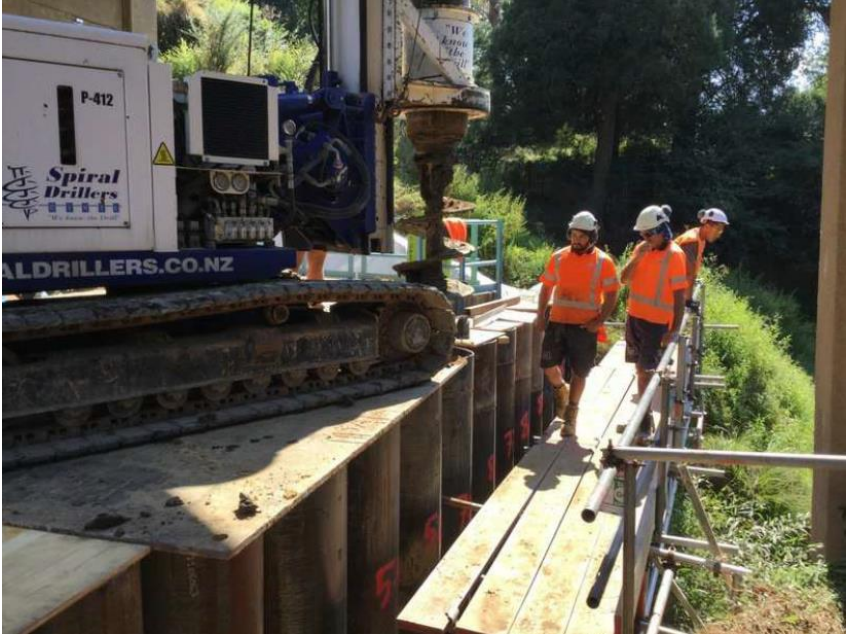
Pier monitoring sensors

Every 3rd pile installed to reduce vibration, 20 metres deep piles. One wet afternoon Pier D decided to move 30mm.

Pier D decided to spring back a little too.

Pier tied to new wall, and lets have a good look at those piles.

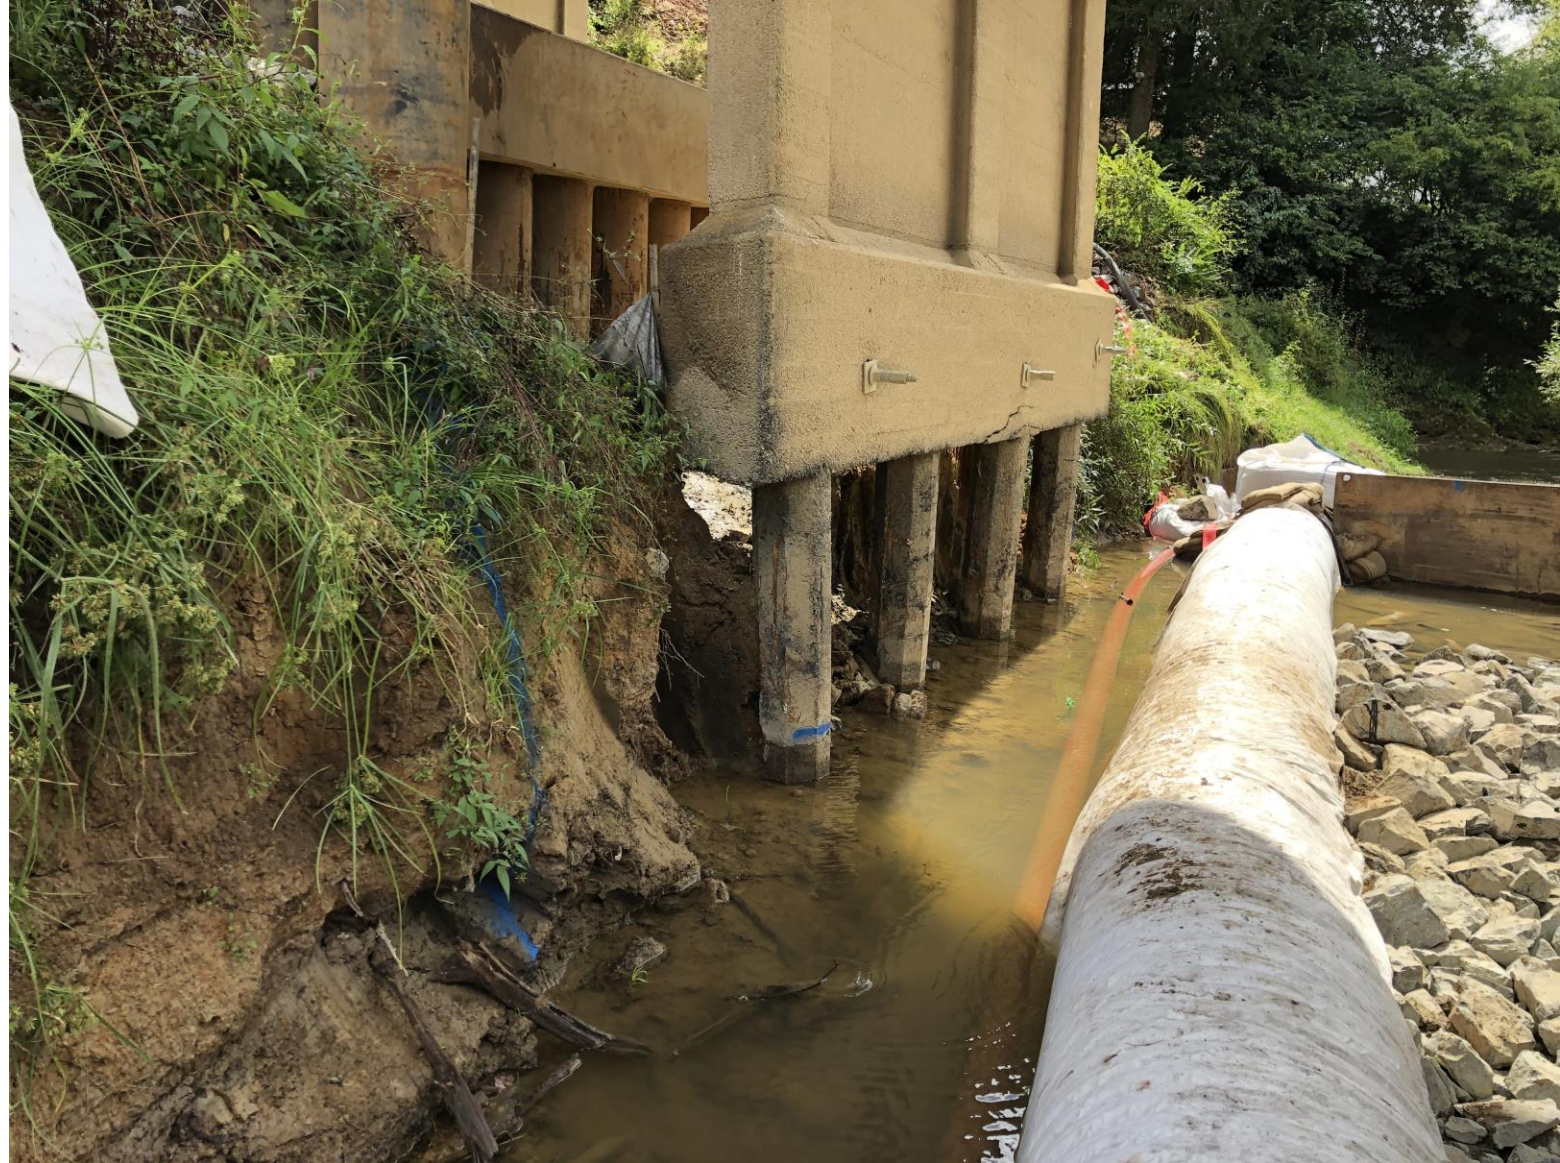
Note the bypass pipe and coffer dam
