Distress Detection using Video Imaging and Artificial Intelligence

Tauranga City Council and Lonrix

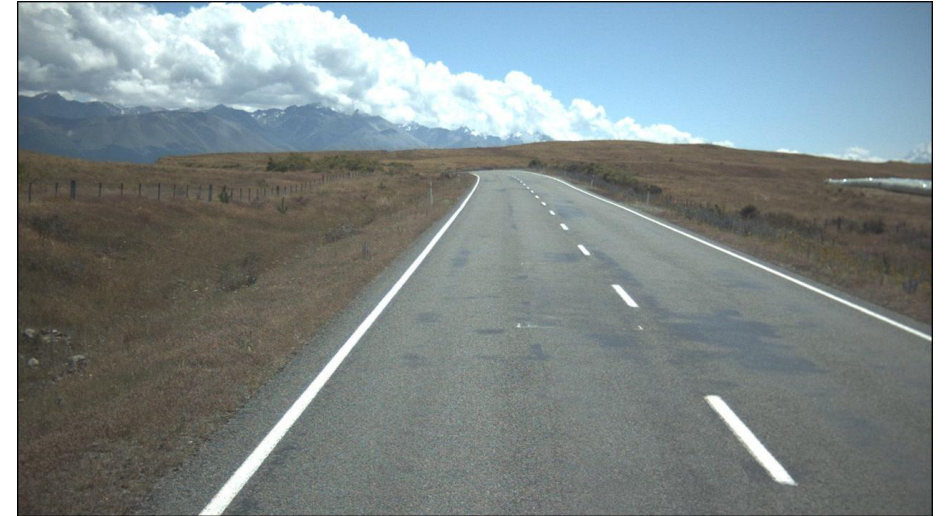
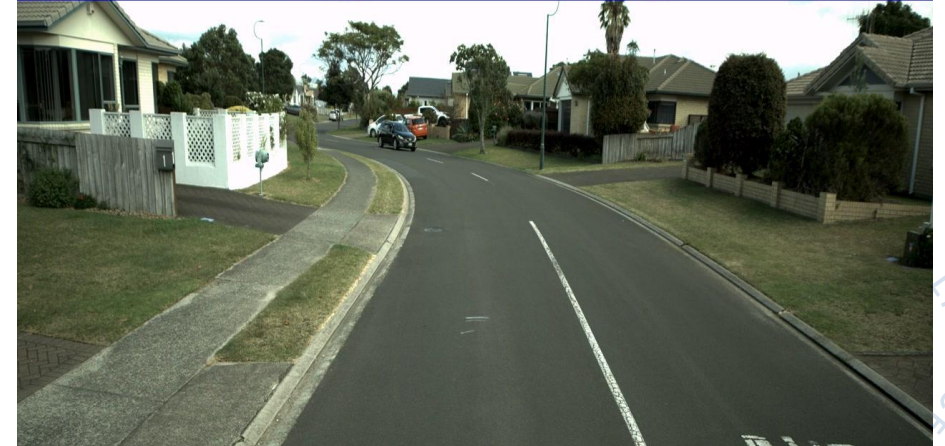
- The quality of videos recorded greatly impact on the detection quality
- Ideal conditions for video capture are **soft light (no sharp shadows)** with a **good exposure** and no **obscuring objects**
- Some examples of good quality images on the right

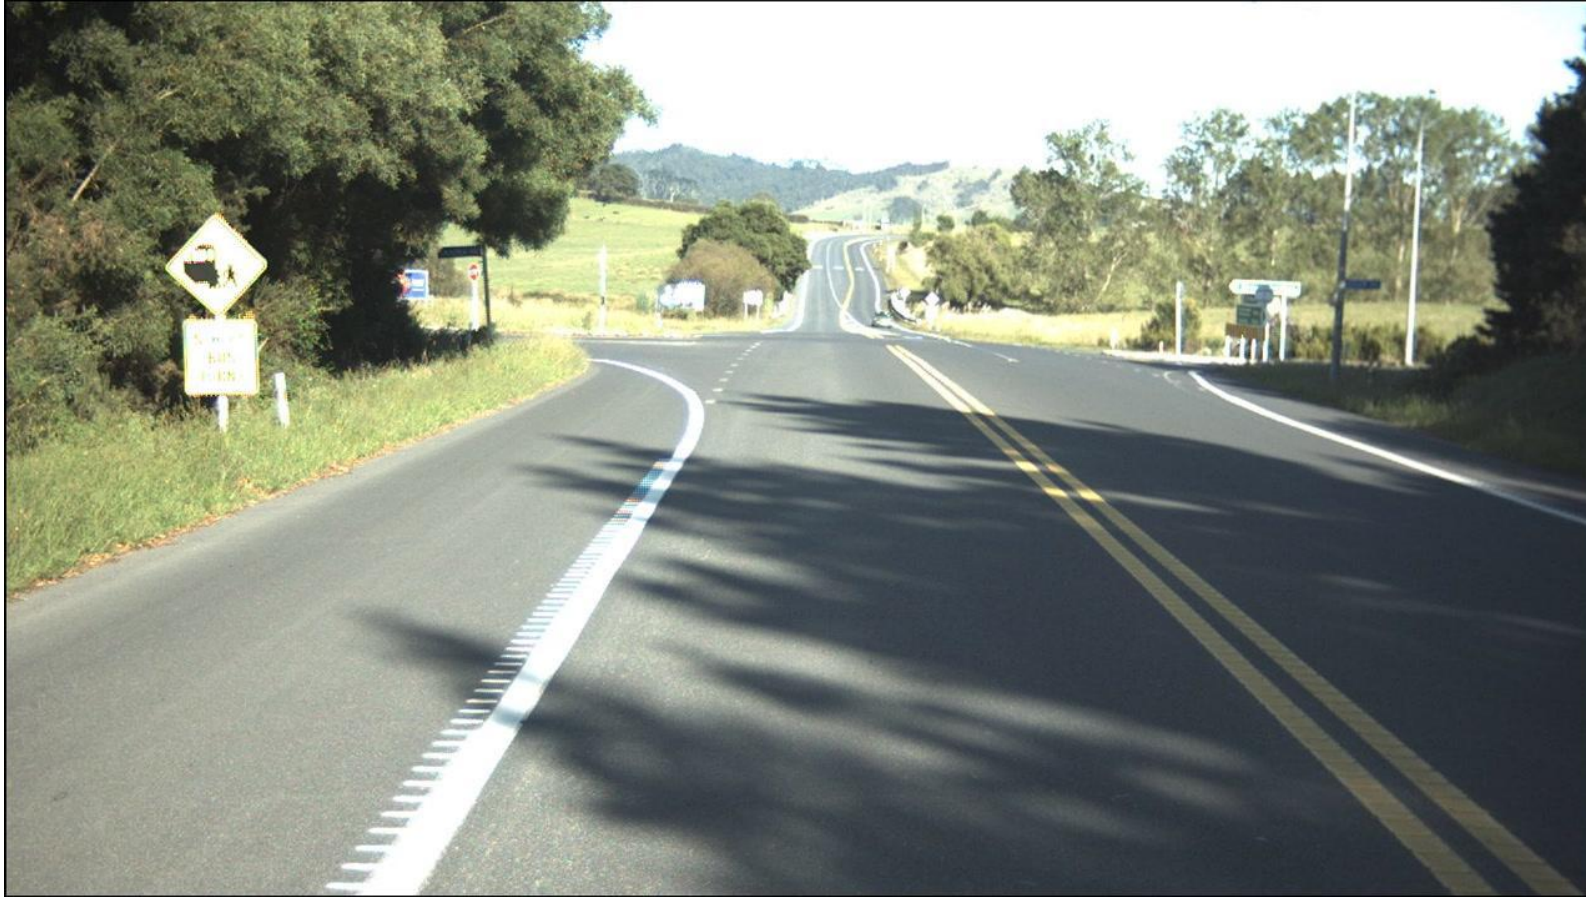
Examples of poor image quality

- Poor quality images can increase **false detections**, e.g. shadows detected as flushing

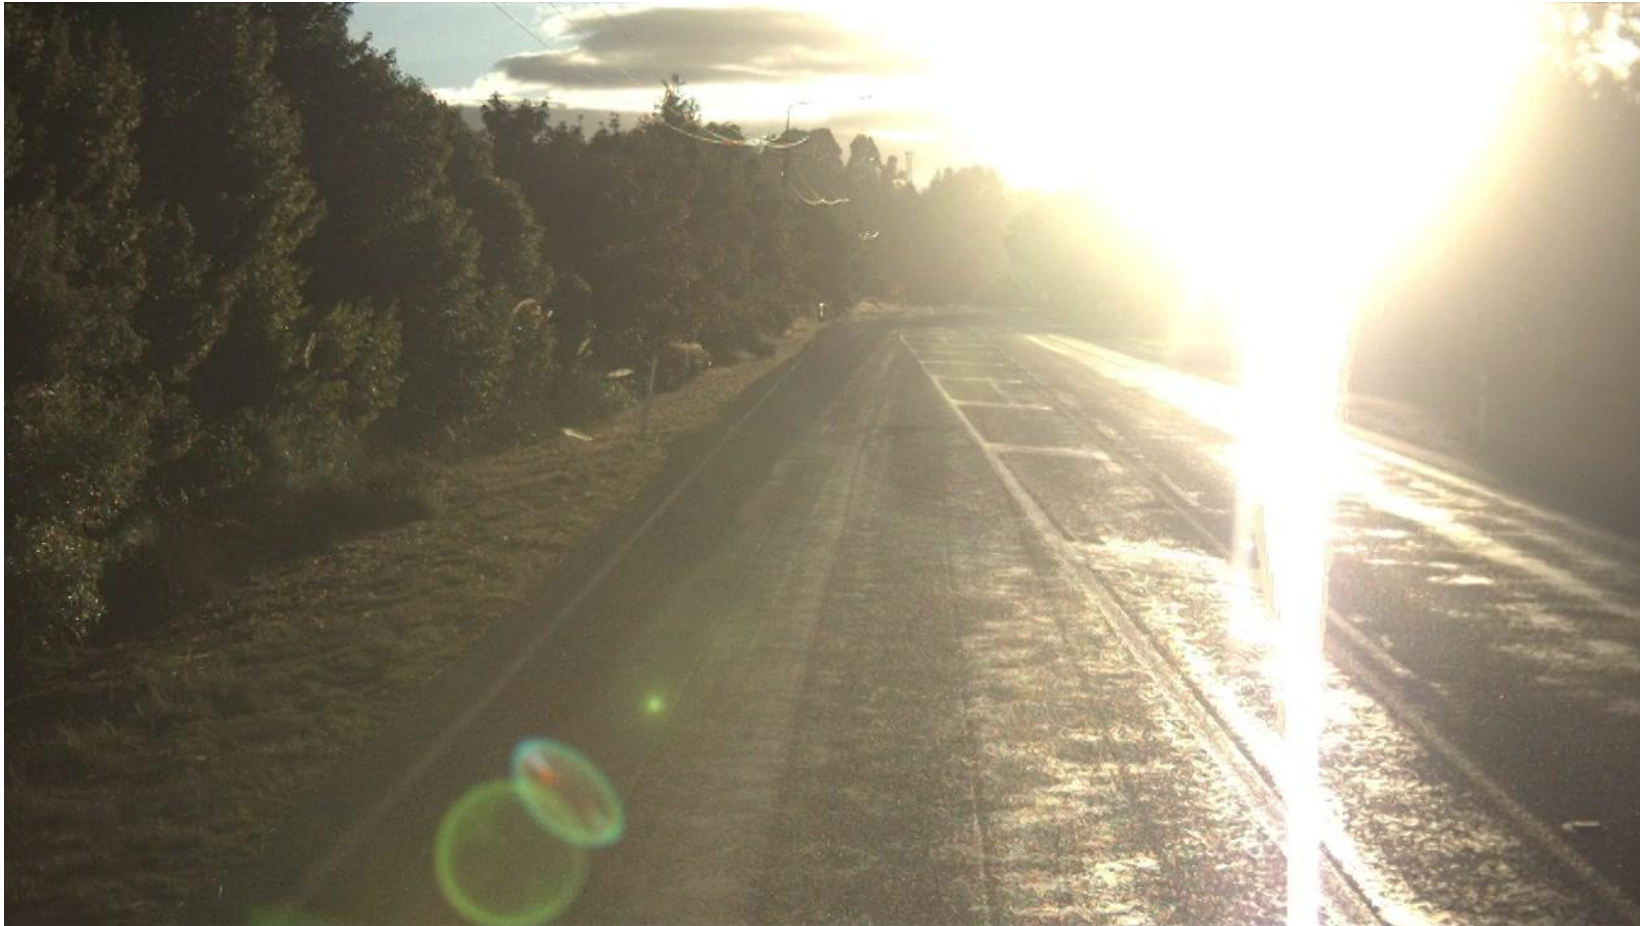
Examples of poor image quality

- Poor quality images can increase **missed detections**, e.g. sunflare

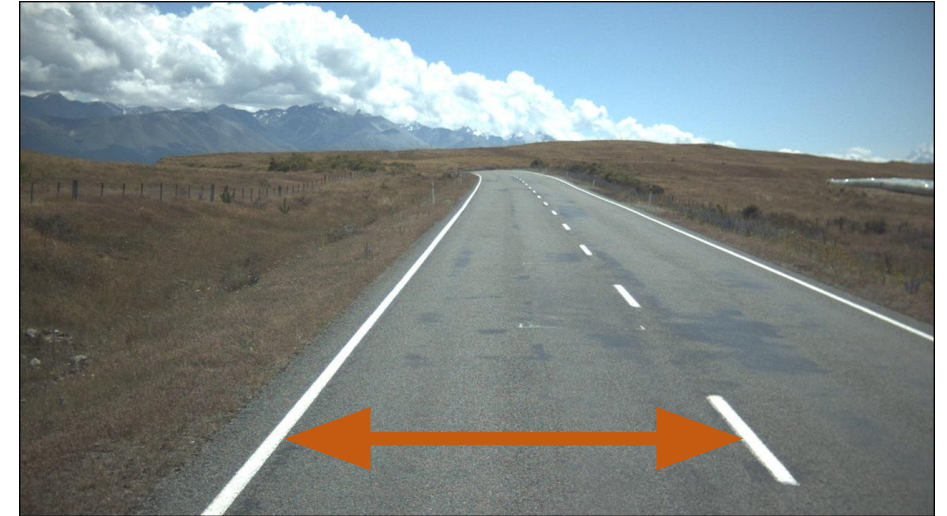
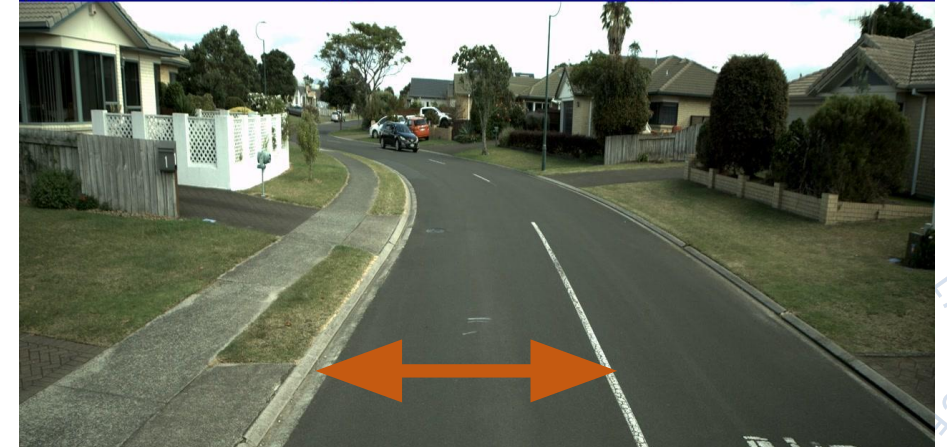
- Consistent camera **angle** and **height** are necessary so that **measurements are as accurate as possible**
- Each video needs **camera calibration factors** calculated
- We usually do this for only a few videos per survey so the camera needs to be in a **fixed position for all videos**
- Example shows two images with different x axis calibration: the lane width is 3.5 or 3m of width in both cases, but pixel width in the image is significantly different

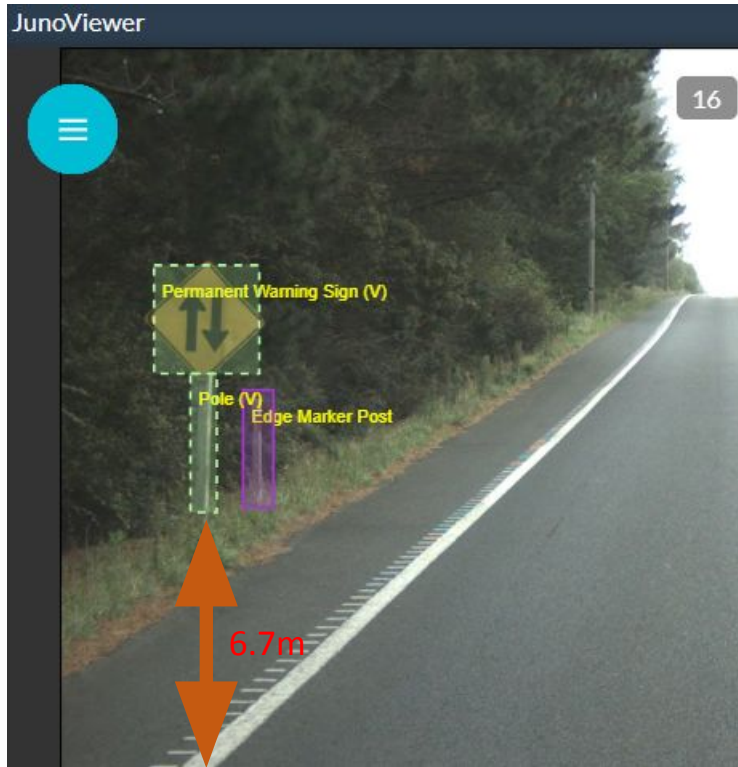
Location of the sign at 22.7 can be estimated using correct calibration factors.

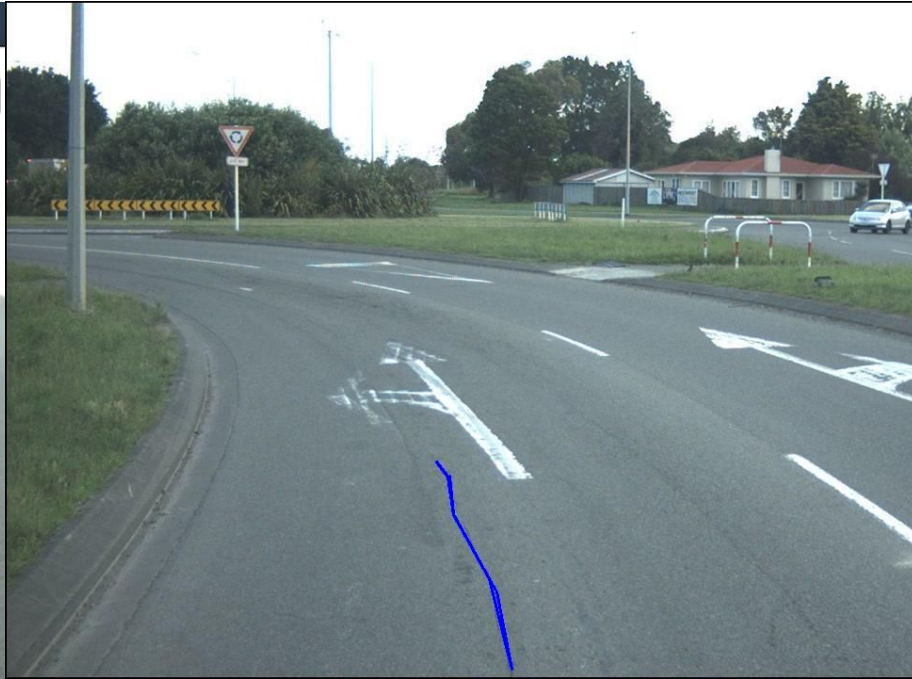
Linear length of a longitudinal crack can also be estimated using correct calibration factors. This one is about 6m.

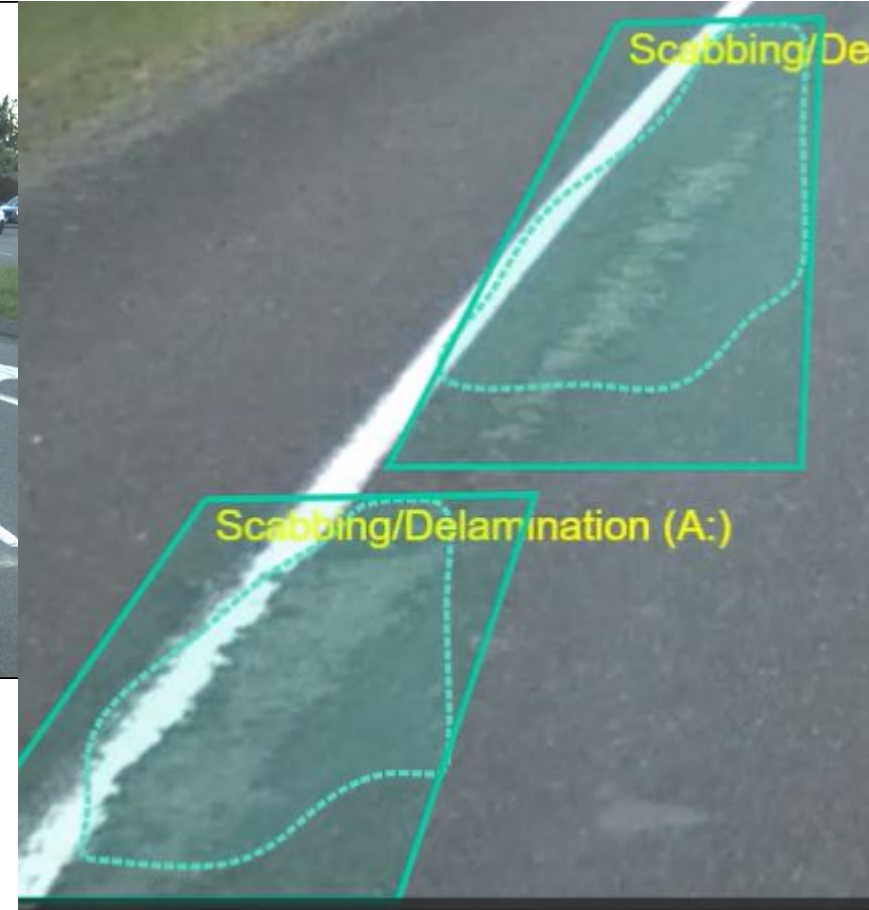
Area of certain faults can be well estimated using correct calibration factors in JV.

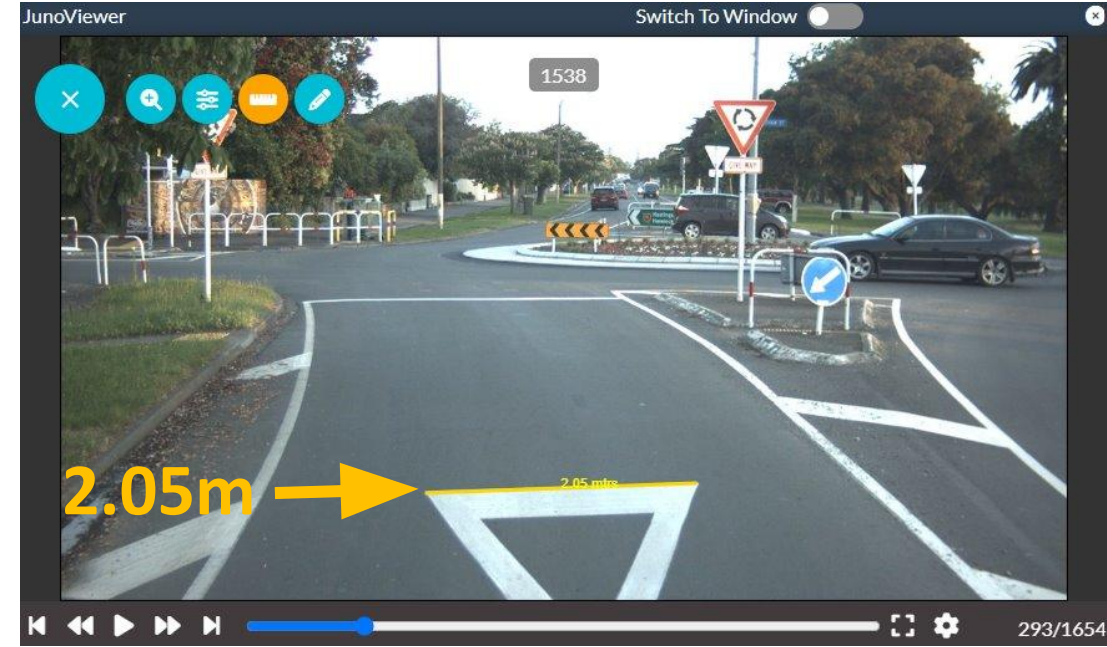
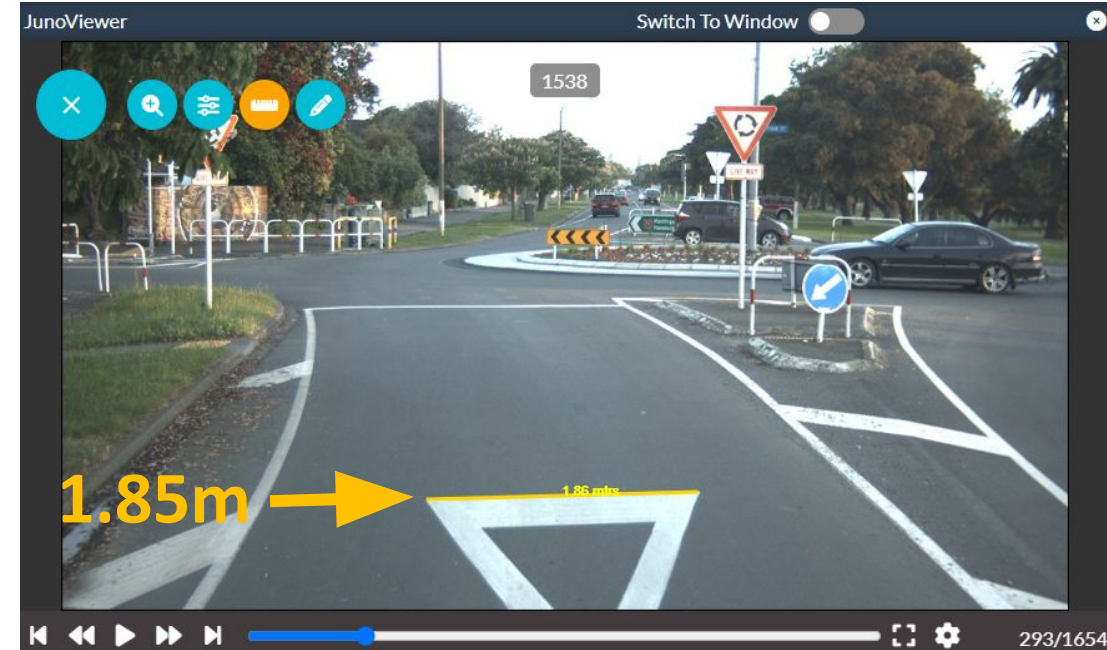
- Sample measurement validation using calibration factors from a different video (above) and one from the same video (below)
- Ground truth MOTSAM guidelines from 2011 state the Give Way triangle should be 1.8m wide

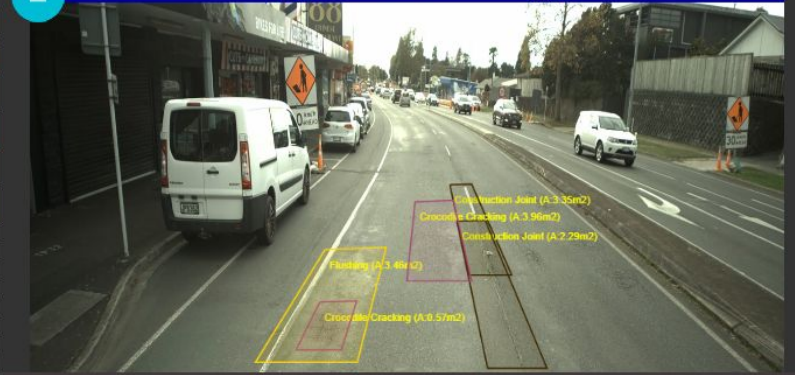
Virtual Field Validation

Survey ID: CAMERON_ROAD_(NORTHBOUND)_06978LL2 Description: SEVENTEENTH AVENUE (LHS) to NINTH AVENUE RAB
